# Access Compliance Report

## Public Rights-of-Way

### (Curb Ramps)

| Intersection ID: 42553 | Main Street: ESTHER_LN | Cross Street: TODDVILLE_RD | Location: NW |

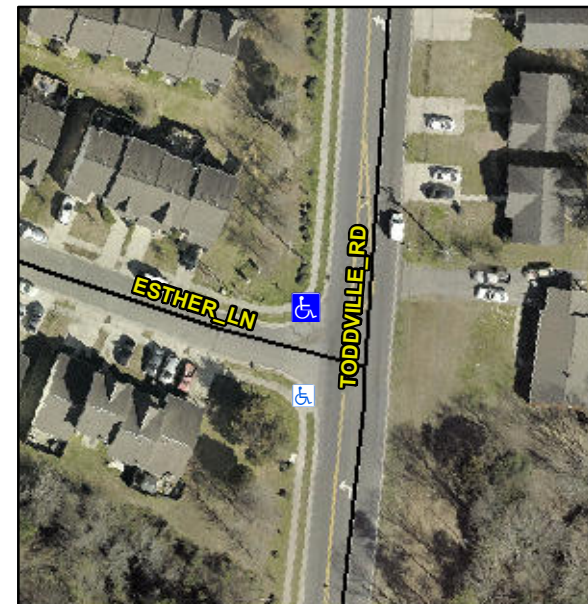
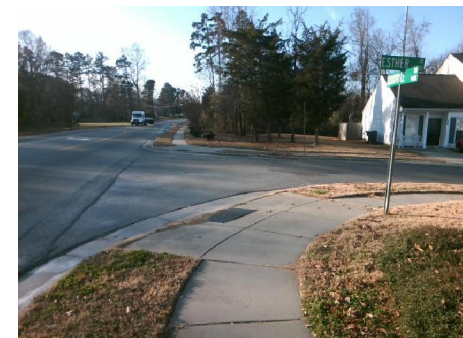
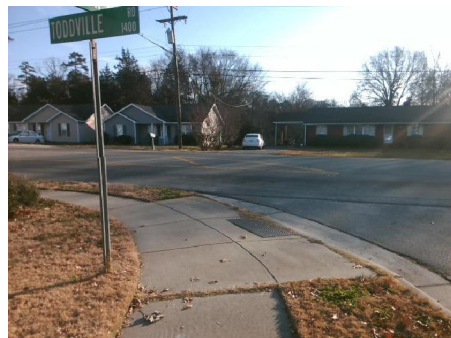
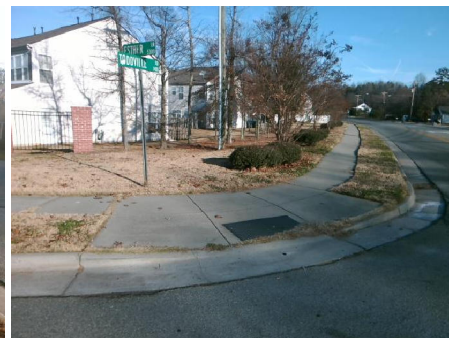
| ADA ID: 1765F85EA496 | Ramp Type: Perp | Initial Pass/Fail: Fail | Overall Compliance: No |
| | | Severity Score: 12.5 | |

**Not Found, R304.2.2**

| Compliance | Description | Data | Compliance | Description | Data |
|---|---|---|---|---|---|
| N/A | Ramp Length (in) | 49.0 | No | Ramp Slope (%) | 9.3 |
| Yes | Ramp Width (in) | 53.0 | Yes | Ramp XSlope (%) | 1.2 |

**Remove & Replace Entire Ramp.**

Total Cost: \$ 1850.00
