Access Compliance Report

Public Rights-of-Way

(Curb Ramps)

Intersection ID: 6323	Main Street: AMHERST_GLEN_DR	Cross Street: BILLINGS_PARK_DR	Location:	N
ADA ID: 176AE8122A6F	Ramp Type: Perp	Initial Pass/Fail: Fail	Overall Compliance: No	Severity Score: 22.5
Codes/Mitigation Info/Possible Solution		Field Measurements/Component Compliance

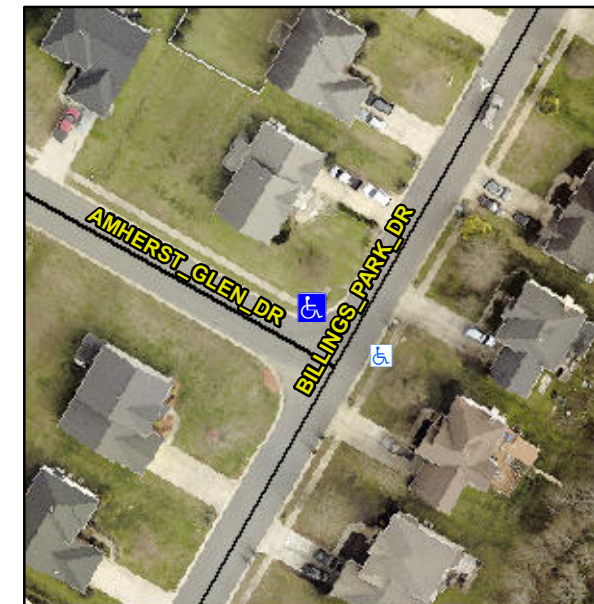
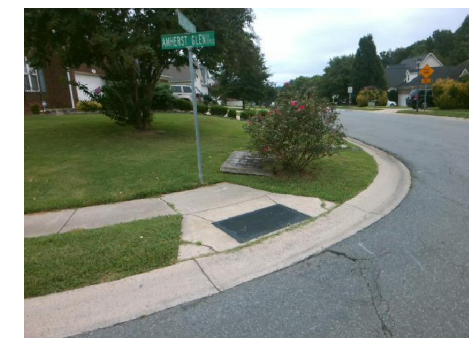
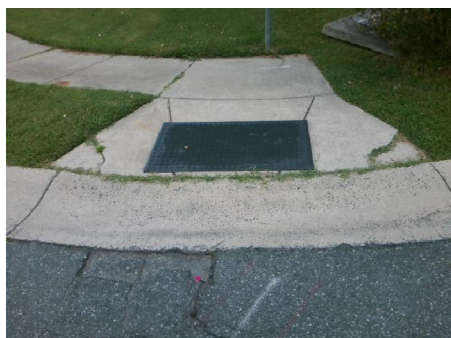
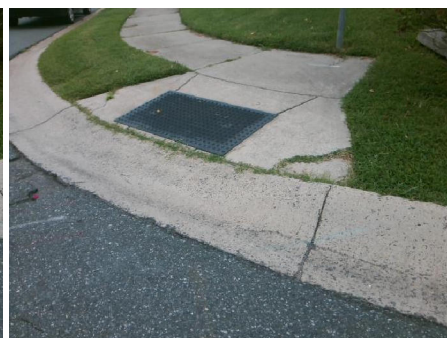
Not Found, R304.5.1, R304.2.2, R304.5.3

Compliance	Description	Data	Compliance	Description	Data
N/A	Ramp Length (in)	48.0	No	Ramp Slope (%)	11.3
No	Ramp Width (in)	44.0	No	Ramp XSlope (%)	3.6
N/A	Flare Type LT	N/A	N/A	Flare Type RT	N/A
N/A	Flare Slope LT (%)	N/A	N/A	Flare Slope RT (%)	N/A
N/A	Flare Traversable LT?	N/A	N/A	Flare Traversable RT?	N/A
N/A	Landing Length (in)	N/A	N/A	DWS Provided?	N/A
N/A	Landing Width (in)	N/A	N/A	DWS Contrast?	N/A
N/A	Landing Slope (%)	N/A	N/A	DWS Length (in)	N/A
N/A	Landing X Slope (%)	N/A	N/A	DWS Full Width?	N/A
N/A	Landing Curb? (Y/N)	N/A	N/A	DWS Offset (in)	N/A
N/A	Shared Landing?	N/A			
N/A	Gutter Ponding?	N/A	N/A	Gutter Slope (%)	N/A
N/A	Gutter Lip Ht (in)	N/A	N/A	Gutter X Slope (%)	N/A
N/A	Painted X Walk1?	No	N/A	Painted X Walk2?	N/A
	X Walk 1 Direction	To SE		X Walk 2 Direction	N/A
N/A	X Walk 1 Width (in)	N/A	N/A	X Walk 2 Width (in)	N/A
	X Walk 1 Slope (%)	3.2		X Walk 2 Slope (%)	N/A
	X Walk 1 X Slope (%)	1.0		X Walk 2 X Slope (%)	N/A

N/A	Ramp inside XWalk1?	N/A	N/A	Ramp inside XWalk2?	N/A
	Road Slope (%)	N/A	N/A	Clear Space?	N/A
	Road X Slope (%)	N/A	N/A	Clear Space to XWalk (in)	N/A
N/A	Any Obstructions?	N/A	N/A	Storm Grate/Utility Hazard?	N/A
	Obstruction Type			Storm Grate/Utility Type	
		N/A			N/A
			Yes	Surface Condition? (G/P)	Good

Possible Solutions:

Remove & Replace Entire Ramp.
