# Access Compliance Report

## Public Rights-of-Way

### (Curb Ramps)

Intersection ID: 28233	Main Street: DARBY_CHASE_DR	Cross Street: N/A	Location: NE
ADA ID: 1778D5222A8A	Ramp Type: Perp	Initial Pass/Fail: Fail	Overall Compliance: No
Severity Score: 47.5			
Codes/Mitigation Info/Possible Solution		Field Measurements/Component Compliance

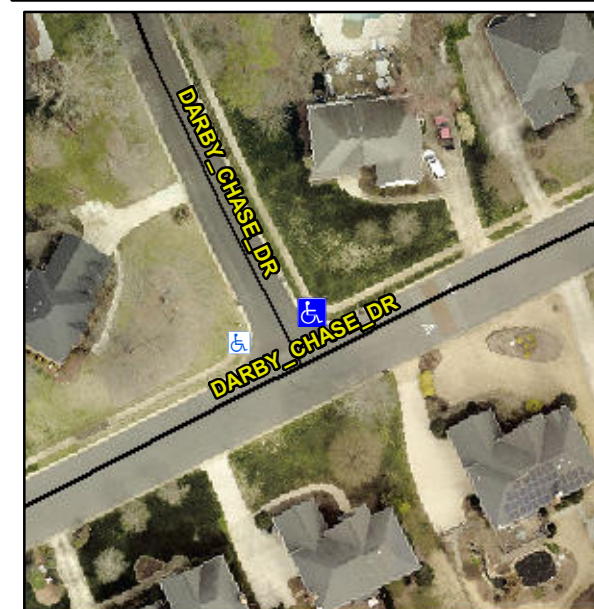
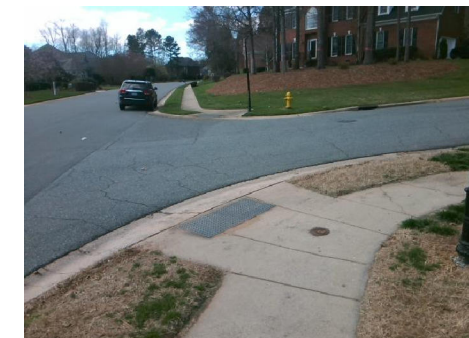
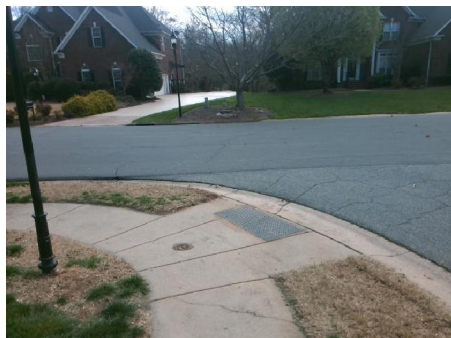
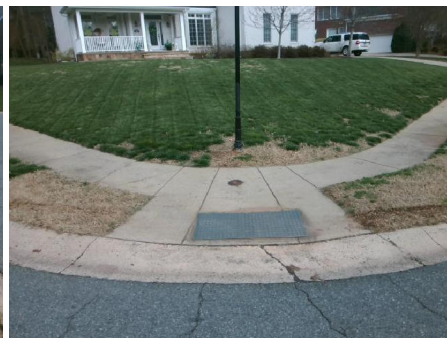
**Not Found, R304.5.1, R304.5.3**

Compliance	Description	Data	Compliance	Description	Data
N/A	Ramp Length (in)	94.0	Yes	Ramp Slope (%)	5.0
No	Ramp Width (in)	25.5	No	Ramp XSlope (%)	5.1
N/A	Flare Type LT	N/A	N/A	Flare Type RT	N/A
N/A	Flare Slope LT (%)	N/A	N/A	Flare Slope RT (%)	N/A
N/A	Flare Traversable LT?	N/A	N/A	Flare Traversable RT?	N/A
N/A	Landing Length (in)	N/A	N/A	DWS Provided?	N/A
N/A	Landing Width (in)	N/A	N/A	DWS Contrast?	N/A
N/A	Landing Slope (%)	N/A	N/A	DWS Length (in)	N/A
N/A	Landing X Slope (%)	N/A	N/A	DWS Full Width?	N/A
N/A	Landing Curb? (Y/N)	N/A	N/A	DWS Offset (in)	N/A
N/A	Shared Landing?	N/A			
N/A	Gutter Ponding?	N/A	N/A	Gutter Slope (%)	N/A
N/A	Gutter Lip Ht (in)	N/A	N/A	Gutter X Slope (%)	N/A
N/A	Painted X Walk1?	No	N/A	Painted X Walk2?	N/A
	X Walk 1 Direction	To SW		X Walk 2 Direction	N/A
N/A	X Walk 1 Width (in)	N/A	N/A	X Walk 2 Width (in)	N/A
	X Walk 1 Slope (%)	2.7		X Walk 2 Slope (%)	N/A
	X Walk 1 X Slope (%)	0.9		X Walk 2 X Slope (%)	N/A

N/A	Ramp inside XWalk1?	N/A	N/A	Ramp inside XWalk2?	N/A
	Road Slope (%)	N/A	N/A	Clear Space?	N/A
	Road X Slope (%)	N/A	N/A	Clear Space to XWalk (in)	N/A
N/A	Any Obstructions?	N/A	N/A	Storm Grate/Utility Hazard?	N/A
	Obstruction Type			Storm Grate/Utility Type	
		N/A			N/A
			Yes	Surface Condition? (G/P)	Good

**Remove & Replace Entire Ramp.**
