Access Compliance Report

Public Rights-of-Way

(Curb Ramps)

Intersection ID: 16824	Main Street: IDLEWILD_RD	Cross Street: LYNMONT_DR	Location: SE
ADA ID: 177B3B8F0934	Ramp Type: PerpDiag	Initial Pass/Fail: Fail	Overall Compliance: No
		Severity Score: 37.5

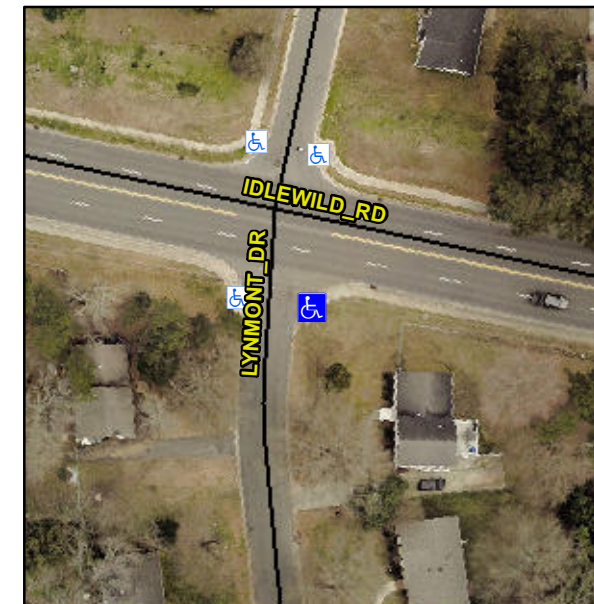
Compliance	Description	Data	Compliance	Description	Data
N/A	Ramp Length (in)	60.0	No	Ramp Slope (%)	9.9
Yes	Ramp Width (in)	48.0	No	Ramp XSlope (%)	9.9
N/A	Flare Type LT	N/A	N/A	Flare Type RT	N/A
N/A	Flare Slope LT (%)	N/A	N/A	Flare Slope RT (%)	N/A
N/A	Flare Traversable LT?	N/A	N/A	Flare Traversable RT?	N/A
N/A	Landing Length (in)	N/A	N/A	DWS Provided?	N/A
N/A	Landing Width (in)	N/A	N/A	DWS Contrast?	N/A
N/A	Landing Slope (%)	N/A	N/A	DWS Length (in)	N/A
N/A	Landing X Slope (%)	N/A	N/A	DWS Full Width?	N/A
N/A	Landing Curb? (Y/N)	N/A	N/A	DWS Offset (in)	N/A
N/A	Shared Landing?	N/A			
N/A	Gutter Ponding?	N/A	N/A	Gutter Slope (%)	N/A
N/A	Gutter Lip Ht (in)	1.0	N/A	Gutter X Slope (%)	N/A
N/A	Painted X Walk1?	No	N/A	Painted X Walk2?	No
	X Walk 1 Direction	To NE		X Walk 2 Direction	To W
N/A	X Walk 1 Width (in)	N/A	N/A	X Walk 2 Width (in)	N/A
	X Walk 1 Slope (%)	9.4		X Walk 2 Slope (%)	0.1
	X Walk 1 X Slope (%)	1.3		X Walk 2 X Slope (%)	8.1

N/A	Ramp inside XWalk1?	N/A	N/A	Ramp inside XWalk2?	N/A
	Road Slope (%)	8.2	N/A	Clear Space?	N/A
	Road X Slope (%)	5.6	N/A	Clear Space to XWalk (in)	N/A
N/A	Any Obstructions?	N/A	N/A	Storm Grate/Utility Hazard?	N/A
	Obstruction Type			Storm Grate/Utility Type	
		N/A			N/A
			Yes	Surface Condition? (G/P)	Good

Remove & Replace Curb Ramp With Two New Directional Ramps or Equivalent.
