Access Compliance Report Public Rights-of-Way (Curb Ramps)

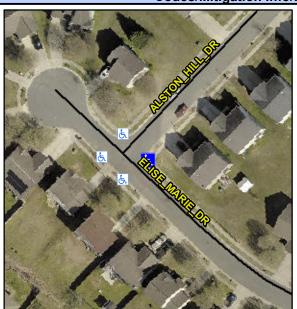
Intersection ID: 31478 Main Street: ALSTON HILL DR Cross Street: ELISE_MARIE_DR Location: ADA ID: 1780652D74A2 Ramp Type: PerpDiag Initial Pass/Fail: Fail **Overall Compliance: No** Severity Score: 33.75

Field Measurements/Component Compliance							
	Compliance Description		Data	Comp	liance	Description	Data
	N/A	Ramp Length (in)	48.0	Yes	Ramp	Slope (%)	7.3
	No	Ramp Width (in)	37.5	No	Ramp	XSlope (%)	7.4
	N/A	Flare Type LT	N/A	N/A	Flare	Type RT	N/A
	N/A	Flare Slope LT (%)	N/A	N/A	Flare	Slope RT (%)	N/A
	N/A	Flare Traversable LT?	N/A	N/A	Flare	Traversable RT?	N/A
	N/A	Landing Length (in)	N/A	N/A	DWS	Provided?	N/A
	N/A	Landing Width (in)	N/A	N/A	DWS	Contrast?	N/A
	N/A	Landing Slope (%)	N/A	N/A	DWS	Length (in)	N/A
	N/A	Landing X Slope (%)	N/A	N/A	DWS	Full Width?	N/A
	N/A	Landing Curb? (Y/N)	N/A	N/A	DWS	Offset (in)	N/A
	N/A	Shared Landing?	N/A				
	N/A	Gutter Ponding?	N/A	N/A	Gutter	Slope (%)	N/A
	N/A	Gutter Lip Ht (in)	0.5	N/A	Gutter	X Slope (%)	N/A
	N/A	Painted X Walk1?	No	N/A	Painte	ed X Walk2?	No
		X Walk 1 Direction	To NW		X Wal	k 2 Direction	To SW
	N/A	X Walk 1 Width (in)	N/A	N/A	X Wal	k 2 Width (in)	N/A

X Walk 1 Slope (%)	0.9		X Wal	k 2 Slope (%)	4.0
		X Walk 1 X Slope (%)	3.7		X Wal	k 2 X Slope (%)	4.6
	N/A	Ramp inside XWalk1?	N/A	N/A	Ramp	inside XWalk2?	N/A
		Road Slope (%)	4.7	N/A	Clear	Space?	N/A
		Road X Slope (%)	1.7	N/A	Clear	Space to XWalk (in)	N/A
	N/A	Any Obstructions?	N/A	N/A	Storm	Grate/Utility Hazard?	N/A
		Obstruction Type			Storm	Grate/Utility Type	
			N/A				N/A
				Yes	Surfac	ce Condition? (G/P)	Good

Possible Solutions: Remove & Replace Curb Ramp With Two New Directional Ramps or Equivalent. Surveyor Notes: N/A PROW/ADA: Not Found, R304.5.1, R304.5.3
