Access Compliance Report

Public Rights-of-Way

(Curb Ramps)

Intersection ID: 10026712	Main Street: FLENNIKEN_CT	Cross Street: N/A	Location: W
ADA ID: 179B678467FF	Ramp Type: BlendTrans1	Initial Pass/Fail: Fail	Overall Compliance: No
		Severity Score: 10

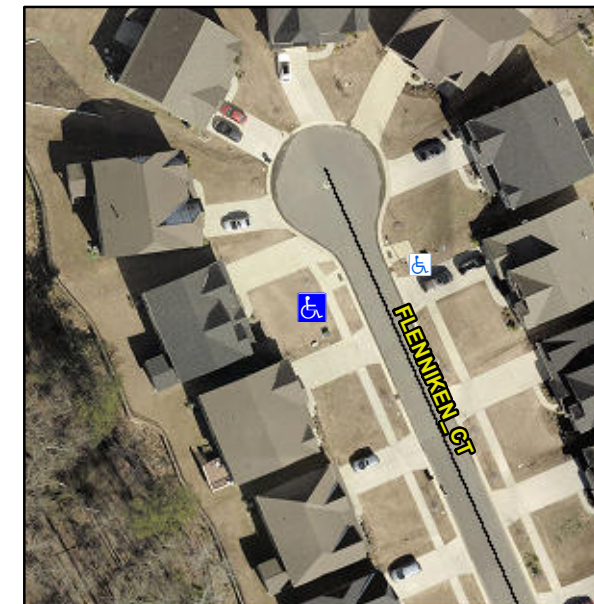
Not Found, R304.5.1, R304.5.3

Compliance	Description	Data	Compliance	Description	Data
N/A	Ramp Length (in)	95.0	Yes	BlendTrans Slope (%)	4.5
No	Ramp Width (in)	46.0	No	BlendTrans XSlope (%)	4.0
N/A	Flare Type LT	N/A	N/A	Flare Type RT	N/A
N/A	Flare Slope LT (%)	N/A	N/A	Flare Slope RT (%)	N/A
N/A	Flare Traversable LT?	N/A	N/A	Flare Traversable RT?	N/A
N/A	Landing Length (in)	N/A	N/A	DWS Provided?	N/A
N/A	Landing Width (in)	N/A	N/A	DWS Contrast?	N/A
N/A	Landing Slope (%)	N/A	N/A	DWS Length (in)	N/A
N/A	Landing X Slope (%)	N/A	N/A	DWS Full Width?	N/A
N/A	Landing Curb? (Y/N)	N/A	N/A	DWS Offset (in)	N/A
N/A	Shared Landing?	N/A			
N/A	Gutter Ponding?	N/A	N/A	Gutter Slope (%)	N/A
N/A	Gutter Lip Ht (in)	N/A	N/A	Gutter X Slope (%)	N/A
N/A	Painted X Walk1?	No	N/A	Painted X Walk2?	N/A
	X Walk 1 Direction	To E		X Walk 2 Direction	N/A
	X Walk 1 Width (in)	N/A		X Walk 2 Width (in)	N/A
	X Walk 1 Slope (%)	2.6		X Walk 2 Slope (%)	N/A
	X Walk 1 X Slope (%)	3.6		X Walk 2 X Slope (%)	N/A

N/A	Ramp inside XWalk1?	N/A	N/A	Ramp inside XWalk2?	N/A
	Road Slope (%)	3.6		Clear Space?	N/A
	Road X Slope (%)	2.6	N/A	Clear Space to XWalk (in)	N/A
N/A	Any Obstructions?	N/A	N/A	Storm Grate/Utility Hazard?	N/A
	Obstruction Type			Storm Grate/Utility Type	
		N/A			N/A
			Yes	Surface Condition? (G/P)	Good
			No	Curb Slope (%)	5.2

Remove & Replace Curb Ramp With Two New Directional Ramps or Equivalent.
