Access Compliance Report

Public Rights-of-Way

(Curb Ramps)

Intersection ID: 46144	Main Street: EASTFIELD_VILLAGE_LN	Cross Street: ROCKY_FORD_CLUB_RD	Location: S
ADA ID: 17A565D54553	Ramp Type: Perp	Initial Pass/Fail: Fail	Overall Compliance: No
			Severity Score: 8.75

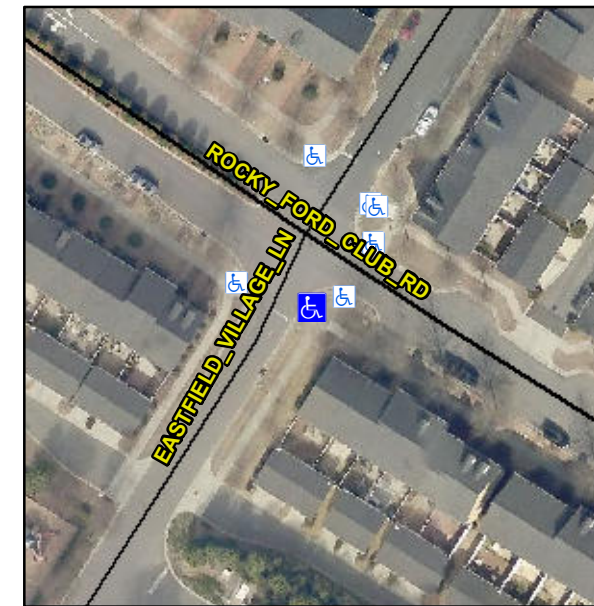
Compliance	Description	Data	Compliance	Description	Data
N/A	Ramp Length (in)	114.0	Yes	Ramp Slope (%)	5.4
No	Ramp Width (in)	46.0	Yes	Ramp XSlope (%)	1.2
N/A	Flare Type LT	N/A	N/A	Flare Type RT	N/A
N/A	Flare Slope LT (%)	N/A	N/A	Flare Slope RT (%)	N/A
N/A	Flare Traversable LT?	N/A	N/A	Flare Traversable RT?	N/A
N/A	Landing Length (in)	N/A	N/A	DWS Provided?	N/A
N/A	Landing Width (in)	N/A	N/A	DWS Contrast?	N/A
N/A	Landing Slope (%)	N/A	N/A	DWS Length (in)	N/A
N/A	Landing X Slope (%)	N/A	N/A	DWS Full Width?	N/A
N/A	Landing Curb? (Y/N)	N/A	N/A	DWS Offset (in)	N/A
N/A	Shared Landing?	N/A			
N/A	Gutter Ponding?	N/A	N/A	Gutter Slope (%)	N/A
N/A	Gutter Lip Ht (in)	N/A	N/A	Gutter X Slope (%)	N/A
N/A	Painted X Walk1?	No	N/A	Painted X Walk2?	N/A
	X Walk 1 Direction	To NW		X Walk 2 Direction	N/A
N/A	X Walk 1 Width (in)	N/A	N/A	X Walk 2 Width (in)	N/A
	X Walk 1 Slope (%)	1.5		X Walk 2 Slope (%)	N/A
	X Walk 1 X Slope (%)	1.4		X Walk 2 X Slope (%)	N/A

N/A	Ramp inside XWalk1?	N/A	N/A	Ramp inside XWalk2?	N/A
	Road Slope (%)	N/A	N/A	Clear Space?	N/A
	Road X Slope (%)	N/A	N/A	Clear Space to XWalk (in)	N/A
N/A	Any Obstructions?	N/A	N/A	Storm Grate/Utility Hazard?	N/A
	Obstruction Type			Storm Grate/Utility Type	
		N/A			N/A
			Yes	Surface Condition? (G/P)	Good

Possible Solutions:

Remove & Replace Entire Ramp.

R304.5.1
