## Access Compliance Report Public Rights-of-Way (Curb Ramps)

Intersection ID: 49655 Main Street: GREENWAY\_CRESCENT\_LN Cross Street: SEIGLE\_POINT\_DR Location: W

ADA ID: 17AAF697B120 Ramp Type: Directional1 Initial Pass/Fail: Fail Overall Compliance: No Severity Score: 13.75

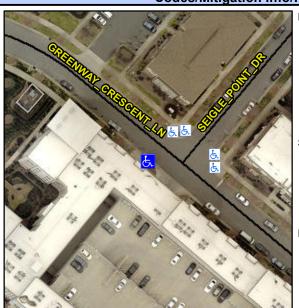
r leid Measurements/Component Compilance						
	Compli	ompliance Description		Compliance Description		Data
	N/A	Ramp Length (in)	90.5	N/A	Grade Break?	N/A
	Yes	Ramp Width (in)	70.0	N/A	Grade Break Slope (%)	0.0
	No	Ramp Slope (%)	9.4	N/A	Grade Break XSlope (%)	0.0
	No	Ramp XSlope (%)	2.9			
	N/A	Flare Type LT	N/A	N/A	Flare Type RT	N/A
	N/A	Flare Slope LT (%)	N/A	N/A	Flare Slope RT (%)	0.0
	N/A	Flare Traversable LT?	N/A	N/A	Flare Traversable RT?	N/A
	N/A	Landing Length (in)	0.0	N/A	DWS Provided?	N/A
	N/A	Landing Width (in)	0.0	N/A	DWS Contrast?	N/A
	N/A	Landing Slope (%)	0.0	N/A	DWS Length (in)	N/A
	N/A	Landing X Slope (%)	0.0	N/A	DWS Full Width?	N/A
	N/A	Landing Curb? (Y/N)	N/A	N/A	DWS Offset LT (in)	N/A
	N/A	Shared Landing?	N/A	N/A	DWS Offset RT (in)	N/A
	N/A	Gutter Ponding?	0.0	N/A	Gutter Slope (%)	N/A
	N/A	Gutter Lip Ht (in)	0.0	N/A	Gutter X Slope (%)	N/A
	N/A	Painted X Walk1?	No		Road Slope (%)	1.6
		X Walk 1 Direction	To NE		Road X Slope (%)	4.7

X Walk 1 Width (in)	N/A	l	Clear Space?	N/A
		X Walk 1 Slope (%)	1.6	N/A	Clear Space to XWalk (in)	N/A
		X Walk 1 X Slope (%)	4.7	N/A	Storm Grate/Utility Hazard?	N/A
	N/A	Ramp inside XWalk1?	N/A		Storm Grate/Utility Type	
	N/A	Any Obstructions?	N/A			N/A
		Obstruction Type		Yes	Surface Condition? (G/P)	Good
			N/A	N/A	Curb Slope (%)	4.1

Total Cost: \$ 1600.00
