Access Compliance Report

Public Rights-of-Way (Curb Ramps)

Intersection ID: 50729	Main Street: TODDINGTON_LN	Cross Street: ALDERGROVE_RD	Location: W
ADA ID: 17B1086C1680	Ramp Type: PerpDiag	Initial Pass/Fail: Fail	Overall Compliance: No
		Severity Score: 8.75

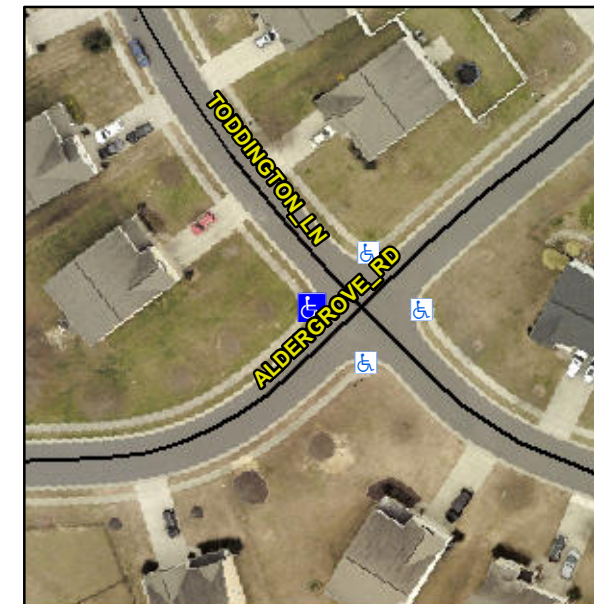
Compliance	Description	Data	Compliance	Description	Data
N/A	Ramp Length (in)	47.5	Yes	Ramp Slope (%)	6.9
No	Ramp Width (in)	47.0	Yes	Ramp XSlope (%)	1.2
N/A	Flare Type LT	N/A	N/A	Flare Type RT	N/A
N/A	Flare Slope LT (%)	N/A	N/A	Flare Slope RT (%)	N/A
N/A	Flare Traversable LT?	N/A	N/A	Flare Traversable RT?	N/A
N/A	Landing Length (in)	N/A	N/A	DWS Provided?	N/A
N/A	Landing Width (in)	N/A	N/A	DWS Contrast?	N/A
N/A	Landing Slope (%)	N/A	N/A	DWS Length (in)	N/A
N/A	Landing X Slope (%)	N/A	N/A	DWS Full Width?	N/A
N/A	Landing Curb? (Y/N)	N/A	N/A	DWS Offset (in)	N/A
N/A	Shared Landing?	N/A			
N/A	Gutter Ponding?	N/A	N/A	Gutter Slope (%)	N/A
N/A	Gutter Lip Ht (in)	N/A	N/A	Gutter X Slope (%)	N/A
N/A	Painted X Walk1?	No	N/A	Painted X Walk2?	No
	X Walk 1 Direction	To SE		X Walk 2 Direction	To NE
N/A	X Walk 1 Width (in)	N/A	N/A	X Walk 2 Width (in)	N/A
	X Walk 1 Slope (%)	2.2		X Walk 2 Slope (%)	2.6
	X Walk 1 X Slope (%)	0.1		X Walk 2 X Slope (%)	3.3

N/A	Ramp inside XWalk1?	N/A	N/A	Ramp inside XWalk2?	N/A
	Road Slope (%)	2.1	N/A	Clear Space?	N/A
	Road X Slope (%)	3.5	N/A	Clear Space to XWalk (in)	N/A
N/A	Any Obstructions?	N/A	N/A	Storm Grate/Utility Hazard?	N/A
	Obstruction Type			Storm Grate/Utility Type	
		N/A			N/A
			Yes	Surface Condition? (G/P)	Good

Possible Solutions:

Remove & Replace Curb Ramp With Two New Directional Ramps or Equivalent.

R304.5.1

Total Cost: \$ 3200.00
