Access Compliance Report

Public Rights-of-Way

(Curb Ramps)

Intersection ID: 14378	Main Street: E_WORTHINGTON_AV	Cross Street: EUCLID_AV	Location: W
ADA ID: 17BBD0C6CF70	Ramp Type: Directional1	Initial Pass/Fail: Fail	Overall Compliance: No
Codes/Mitigation Info/Possible Solution		Field Measurements/Component Compliance	
Severity Score: 1.25

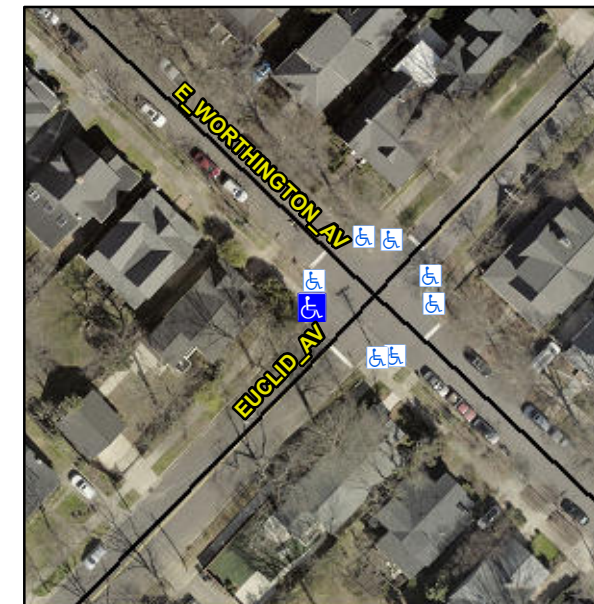
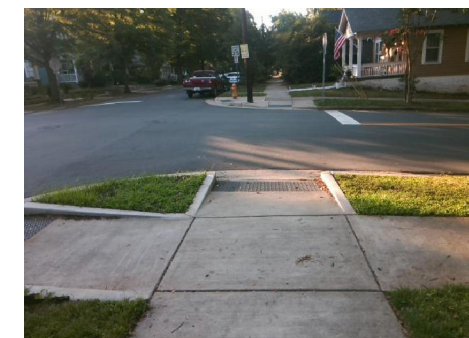
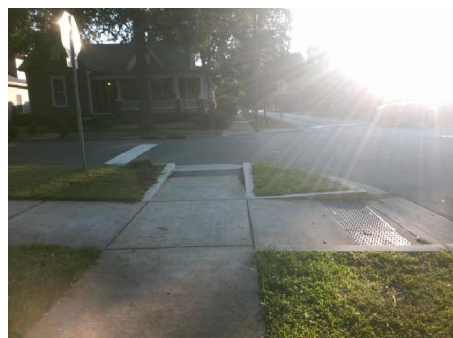
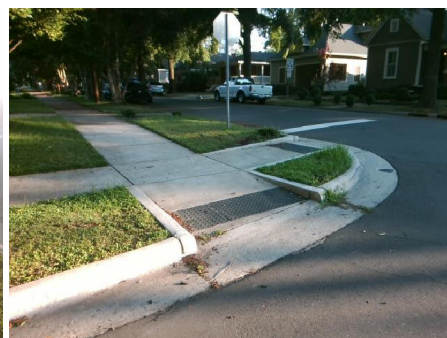
Compliance	Description	Data	Compliance	Description	Data
N/A	Ramp Length (in)	67.0	N/A	Grade Break?	N/A
Yes	Ramp Width (in)	71.0	N/A	Grade Break Slope (%)	0.0
Yes	Ramp Slope (%)	7.7	N/A	Grade Break XSlope (%)	0.0
No	Ramp XSlope (%)	2.2			
N/A	Flare Type LT	N/A	N/A	Flare Type RT	N/A
N/A	Flare Slope LT (%)	N/A	N/A	Flare Slope RT (%)	0.0
N/A	Flare Traversable LT?	N/A	N/A	Flare Traversable RT?	N/A
N/A	Landing Length (in)	0.0	N/A	DWS Provided?	N/A
N/A	Landing Width (in)	0.0	N/A	DWS Contrast?	N/A
N/A	Landing Slope (%)	0.0	N/A	DWS Length (in)	N/A
N/A	Landing X Slope (%)	0.0	N/A	DWS Full Width?	N/A
N/A	Landing Curb? (Y/N)	N/A	N/A	DWS Offset LT (in)	N/A
N/A	Shared Landing?	N/A	N/A	DWS Offset RT (in)	N/A
N/A	Gutter Ponding?	0.0	N/A	Gutter Slope (%)	N/A
N/A	Gutter Lip Ht (in)	0.0	N/A	Gutter X Slope (%)	N/A
N/A	Painted X Walk1?	No		Road Slope (%)	4.0
	X Walk 1 Direction	To SE		Road X Slope (%)	6.9
	X Walk 1 Width (in)	N/A		Clear Space?	N/A

X Walk 1 Slope (%)	4.0	N/A	Clear Space to XWalk (in)	N/A
	X Walk 1 X Slope (%)	6.9	N/A	Storm Grate/Utility Hazard?	N/A
N/A	Ramp inside XWalk1?	N/A		Storm Grate/Utility Type	
N/A	Any Obstructions?	N/A			N/A
	Obstruction Type		Yes	Surface Condition? (G/P)	Good
			N/A	Curb Slope (%)	6.9

Remove & Replace Entire Ramp.

R304.5.3

\$ 1600.00
