Access Compliance Report

Public Rights-of-Way

(Curb Ramps)

Intersection ID: 10014838	Main Street: THE_PLAZA	Cross Street: N/A	Location: NW
ADA ID: 17BE37756716	Ramp Type: PerpDiag	Initial Pass/Fail: Fail	Overall Compliance: No
		Severity Score: 12.5

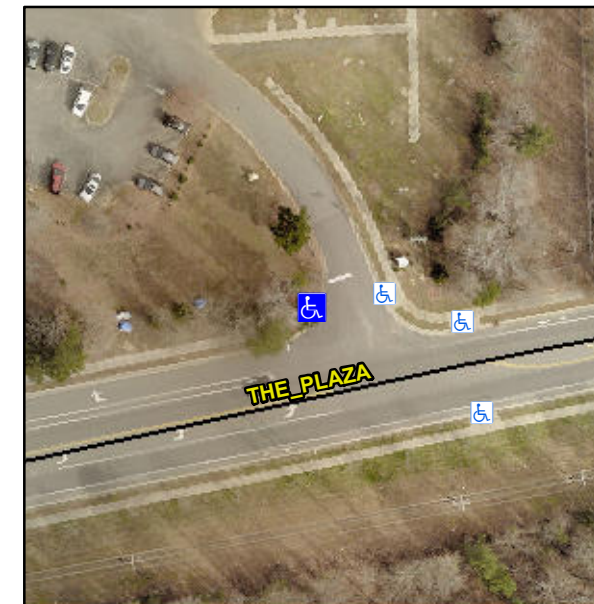
Not Found, R304.5.3

Compliance	Description	Data	Compliance	Description	Data
N/A	Ramp Length (in)	47.0	Yes	Ramp Slope (%)	6.5
Yes	Ramp Width (in)	48.0	No	Ramp XSlope (%)	6.1
N/A	Flare Type LT	N/A	N/A	Flare Type RT	N/A
N/A	Flare Slope LT (%)	N/A	N/A	Flare Slope RT (%)	N/A
N/A	Flare Traversable LT?	N/A	N/A	Flare Traversable RT?	N/A
N/A	Landing Length (in)	N/A	N/A	DWS Provided?	N/A
N/A	Landing Width (in)	N/A	N/A	DWS Contrast?	N/A
N/A	Landing Slope (%)	N/A	N/A	DWS Length (in)	N/A
N/A	Landing X Slope (%)	N/A	N/A	DWS Full Width?	N/A
N/A	Landing Curb? (Y/N)	N/A	N/A	DWS Offset (in)	N/A
N/A	Shared Landing?	N/A			
N/A	Gutter Ponding?	N/A	N/A	Gutter Slope (%)	N/A
N/A	Gutter Lip Ht (in)	N/A	N/A	Gutter X Slope (%)	N/A
N/A	Painted X Walk1?	No	N/A	Painted X Walk2?	No
	X Walk 1 Direction	To S		X Walk 2 Direction	To E
N/A	X Walk 1 Width (in)	N/A	N/A	X Walk 2 Width (in)	N/A
	X Walk 1 Slope (%)	2.6		X Walk 2 Slope (%)	3.2
	X Walk 1 X Slope (%)	5.0		X Walk 2 X Slope (%)	2.1

N/A	Ramp inside XWalk1?	N/A	N/A	Ramp inside XWalk2?	N/A
	Road Slope (%)	4.7	N/A	Clear Space?	N/A
	Road X Slope (%)	1.8	N/A	Clear Space to XWalk (in)	N/A
N/A	Any Obstructions?	N/A	N/A	Storm Grate/Utility Hazard?	N/A
	Obstruction Type			Storm Grate/Utility Type	
		N/A			N/A
			Yes	Surface Condition? (G/P)	Good

Possible Solutions:

Remove & Replace Curb Ramp With Two New Directional Ramps or Equivalent.

Total Cost: \$ 3200.00
