# Access Compliance Report

## Public Rights-of-Way

### (Curb Ramps)

| Intersection ID: 18018 | Main Street: GILMORE_DR | Cross Street: INWOOD_DR | Location: SW |

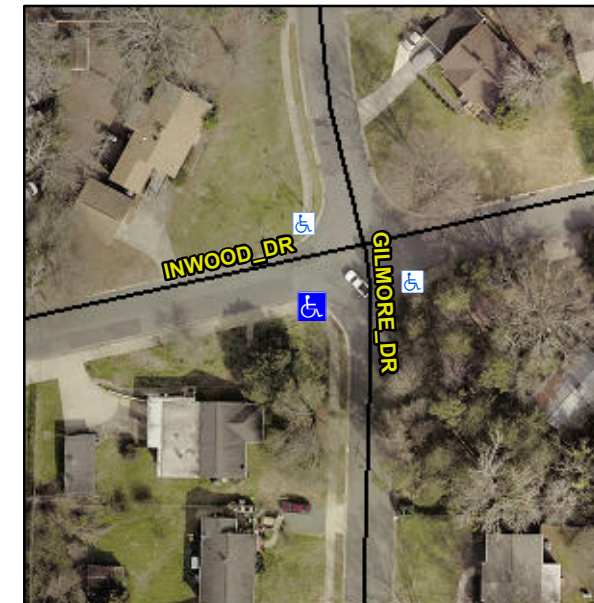
| ADA ID: 17BF0A330CF1 | Ramp Type: BlendTrans2 | Initial Pass/Fail: Pass | Overall Compliance: No |
| | | Severity Score: 12.75 | |

**Not Found, R304.5.3, R302.7.2, R304.5.4**

| Compliance | Description | Data | Compliance | Description | Data |
|---|---|---|---|---|---|
| Yes | Ramp Width (in) | 48.0 | No | BlendTrans XSlope (%) | 2.9 |
| Yes | Gutter Ponding? | No | No | Gutter Slope (%) | 6.8 |
| No | Gutter Lip Ht (in) | 0.5 | No | Gutter X Slope (%) | 2.6 |
| | | | No | Curb Slope (%) | 20.5 |

**Remove & Replace Curb Ramp With Two New Directional Ramps or Equivalent. Remove & Replace Gutter.**

Total Cost: \$ 3950.00
