# Access Compliance Report

## Public Rights-of-Way

| Intersection ID: 16905 | Main Street: BILTMORE_DR | Cross Street: SCOTLAND_AV | Location: W |
| ADA ID: 17CE66E58443 | Ramp Type: Perp | Initial Pass/Fail: Fail | Overall Compliance: No |

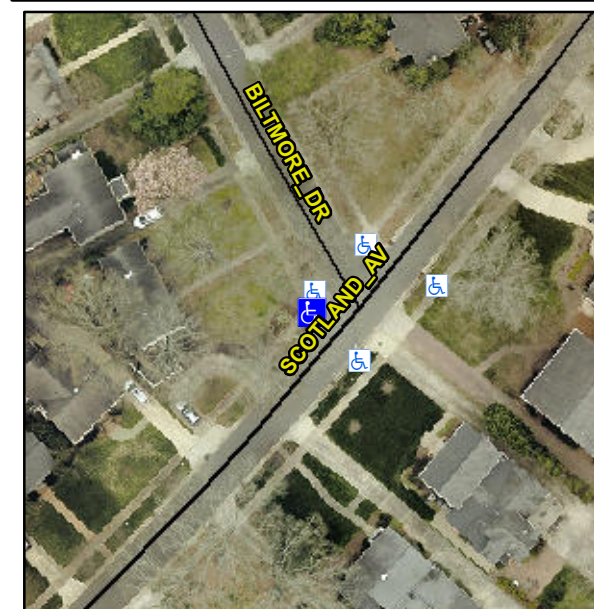
| Severity Score: 13.75 | | | |

**R304.2.2, R304.5.3**

| Compliance | Description | Data | Compliance | Description | Data |
|---|---|---|---|---|---|
| N/A | Ramp Length (in) | 89.0 | No | Ramp Slope (%) | 10.1 |
| Yes | Ramp Width (in) | 57.0 | No | Ramp XSlope (%) | 3.3 |

**Remove & Replace Entire Ramp.**

Total Cost: \$ 1850.00
