Access Compliance Report

Public Rights-of-Way

(Curb Ramps)

Intersection ID: 15211	Main Street: EAST_BV	Cross Street: SCOTT_AV	Location: S
ADA ID: 17D24F80CC9D	Ramp Type: BlendTrans2	Initial Pass/Fail: Fail	Overall Compliance: No
Severity Score: 25			
Codes/Mitigation Info/Possible Solution		Field Measurements/Component Compliance

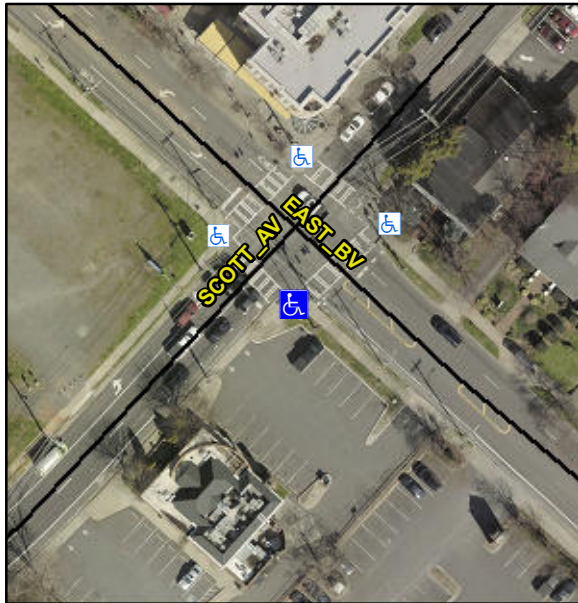
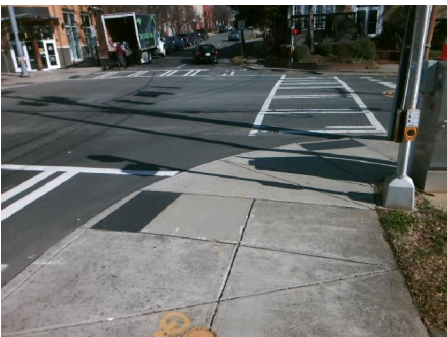
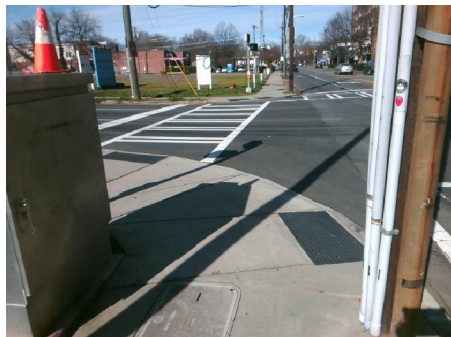
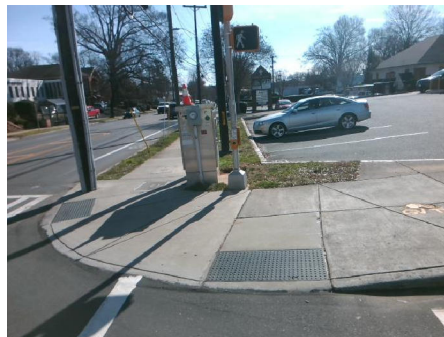
Not Found, R304.5.3

Compliance	Description	Data	Compliance	Description	Data
N/A	Ramp Length (in)	135.0	Yes	BlendTrans Slope (%)	4.8
Yes	Ramp Width (in)	132.0	No	BlendTrans XSlope (%)	11.6
N/A	Flare Type LT	N/A	N/A	Flare Type RT	N/A
N/A	Flare Slope LT (%)	N/A	N/A	Flare Slope RT (%)	N/A
N/A	Flare Traversable LT?	N/A	N/A	Flare Traversable RT?	N/A
N/A	Landing Length (in)	N/A	N/A	DWS Provided?	N/A
N/A	Landing Width (in)	N/A	N/A	DWS Contrast?	N/A
N/A	Landing Slope (%)	N/A	N/A	DWS Length (in)	N/A
N/A	Landing X Slope (%)	N/A	N/A	DWS Full Width?	N/A
N/A	Landing Curb? (Y/N)	N/A	N/A	DWS Offset (in)	N/A
N/A	Shared Landing?	N/A			
N/A	Gutter Ponding?	N/A	N/A	Gutter Slope (%)	N/A
N/A	Gutter Lip Ht (in)	N/A	N/A	Gutter X Slope (%)	N/A
N/A	Painted X Walk1?	Yes	N/A	Painted X Walk2?	Yes
	X Walk 1 Direction	To NE		X Walk 2 Direction	To NW
	X Walk 1 Width (in)	113.0		X Walk 2 Width (in)	106.0
	X Walk 1 Slope (%)	4.3		X Walk 2 Slope (%)	0.8
	X Walk 1 X Slope (%)	2.7		X Walk 2 X Slope (%)	2.3

N/A	Ramp inside XWalk1?	Yes	N/A	Ramp inside XWalk2?	Yes
	Road Slope (%)	3.5		Clear Space?	N/A
	Road X Slope (%)	1.6	N/A	Clear Space to XWalk (in)	N/A
N/A	Any Obstructions?	N/A	N/A	Storm Grate/Utility Hazard?	N/A
	Obstruction Type			Storm Grate/Utility Type	
		N/A			N/A
		Yes		Surface Condition? (G/P)	Good
		No		Curb Slope (%)	6.0

Possible Solutions:

Remove & Replace Curb Ramp With Two New Directional Ramps or Equivalent.
