Access Compliance Report

Public Rights-of-Way

(Curb Ramps)

Intersection ID: 16232	Main Street: ANSON_ST	Cross Street: HOLLIS_RD	Location:	E
ADA ID: 17D80C0A59A4	Ramp Type: Directional1	Initial Pass/Fail: Fail	Overall Compliance: No	Severity Score: 13.75
Codes/Mitigation Info/Possible Solution		Field Measurements/Component Compliance

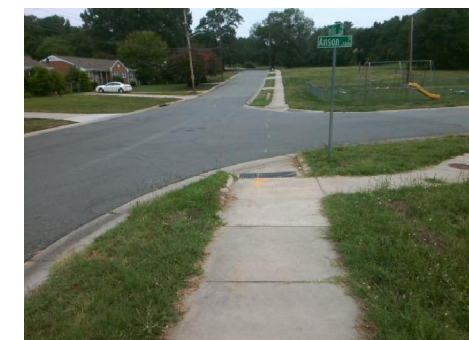
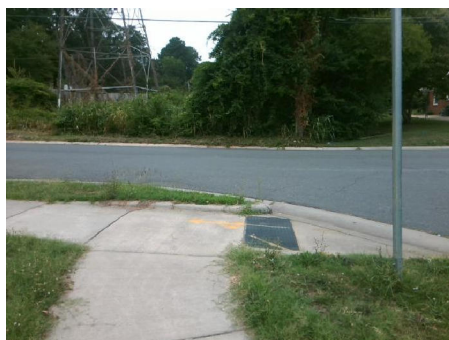
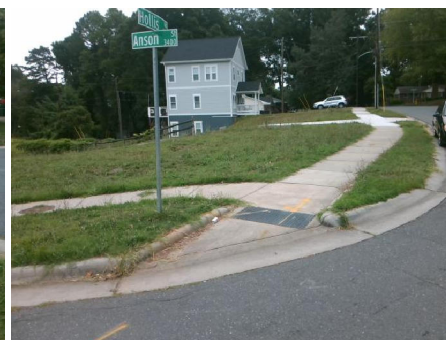
Compliance	Description	Data	Compliance	Description	Data
N/A	Ramp Length (in)	129.0	N/A	Grade Break?	N/A
Yes	Ramp Width (in)	59.0	N/A	Grade Break Slope (%)	0.0
No	Ramp Slope (%)	8.5	N/A	Grade Break XSlope (%)	0.0
No	Ramp XSlope (%)	2.2			
N/A	Flare Type LT	N/A	N/A	Flare Type RT	N/A
N/A	Flare Slope LT (%)	N/A	N/A	Flare Slope RT (%)	0.0
N/A	Flare Traversable LT?	N/A	N/A	Flare Traversable RT?	N/A
N/A	Landing Length (in)	0.0	N/A	DWS Provided?	N/A
N/A	Landing Width (in)	0.0	N/A	DWS Contrast?	N/A
N/A	Landing Slope (%)	0.0	N/A	DWS Length (in)	N/A
N/A	Landing X Slope (%)	0.0	N/A	DWS Full Width?	N/A
N/A	Landing Curb? (Y/N)	N/A	N/A	DWS Offset LT (in)	N/A
N/A	Shared Landing?	N/A	N/A	DWS Offset RT (in)	N/A
N/A	Gutter Ponding?	0.0	N/A	Gutter Slope (%)	N/A
N/A	Gutter Lip Ht (in)	0.0	N/A	Gutter X Slope (%)	N/A
N/A	Painted X Walk1?	No		Road Slope (%)	1.7
	X Walk 1 Direction	To NW		Road X Slope (%)	4.4
	X Walk 1 Width (in)	N/A		Clear Space?	N/A

X Walk 1 Slope (%)	1.7	N/A	Clear Space to XWalk (in)	N/A
	X Walk 1 X Slope (%)	4.4	N/A	Storm Grate/Utility Hazard?	N/A
N/A	Ramp inside XWalk1?	N/A		Storm Grate/Utility Type	
N/A	Any Obstructions?	N/A			N/A
	Obstruction Type		Yes	Surface Condition? (G/P)	Good
			N/A	Curb Slope (%)	10.2

Possible Solutions:

Remove & Replace Entire Ramp.

R304.2.2, R304.5.3
