Access Compliance Report

Public Rights-of-Way

(Curb Ramps)

Intersection ID: 18173	Main Street: COLONY_RD	Cross Street: PICARDY_PL	Location: SW
ADA ID: 17E17564B845	Ramp Type: Perp	Initial Pass/Fail: Fail	Overall Compliance: No
			Severity Score: 26.25

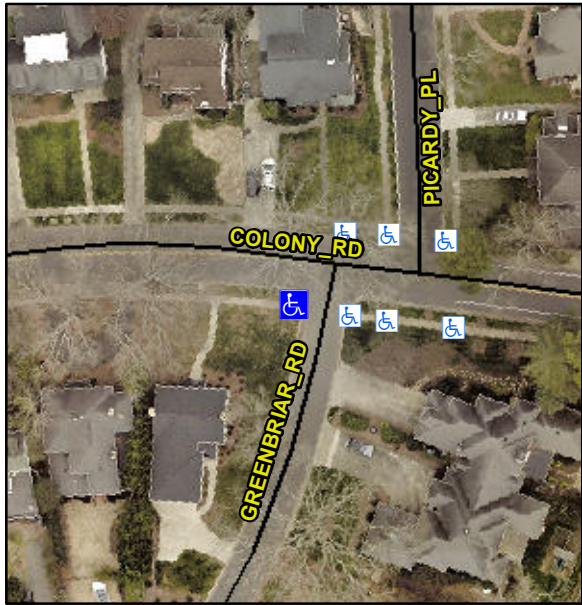
<p>Street 1 Name GREENBRIAR RD</p> <p>Stop Condition-Street 2 StopSign</p> <p>Street 2 Name N/A</p> <p>Stop Condition-Street 1 N/A</p>	Possible Solutions:		Compliance	Description	Data	Compliance	Description	Data
	Remove & Replace Entire Ramp.		N/A	Ramp Length (in)	31.5	No	Ramp Slope (%)	14.6
			Yes	Ramp Width (in)	48.0	No	Ramp XSlope (%)	3.0
			N/A	Flare Type LT	N/A	N/A	Flare Type RT	N/A
			N/A	Flare Slope LT (%)	N/A	N/A	Flare Slope RT (%)	N/A
			N/A	Flare Traversable LT?	N/A	N/A	Flare Traversable RT?	N/A
			N/A	Landing Length (in)	N/A	N/A	DWS Provided?	N/A
			N/A	Landing Width (in)	N/A	N/A	DWS Contrast?	N/A
			N/A	Landing Slope (%)	N/A	N/A	DWS Length (in)	N/A
			N/A	Landing X Slope (%)	N/A	N/A	DWS Full Width?	N/A
Surveyor Notes:		N/A	N/A	Landing Curb? (Y/N)	N/A	N/A	DWS Offset (in)	N/A
PROW/ADA:		Not Found, R304.2.2, R304.5.3	N/A	Shared Landing?	N/A

N/A	Gutter Ponding?	N/A	N/A	Gutter Slope (%)	N/A
			N/A	Gutter Lip Ht (in)	N/A	N/A	Gutter X Slope (%)	N/A
			N/A	Painted X Walk1?	No	N/A	Painted X Walk2?	N/A
				X Walk 1 Direction	To SE		X Walk 2 Direction	N/A
			N/A	X Walk 1 Width (in)	N/A	N/A	X Walk 2 Width (in)	N/A
				X Walk 1 Slope (%)	2.1		X Walk 2 Slope (%)	N/A
				X Walk 1 X Slope (%)	0.6		X Walk 2 X Slope (%)	N/A
			N/A	Ramp inside XWalk1?	N/A	N/A	Ramp inside XWalk2?	N/A
				Road Slope (%)	N/A	N/A	Clear Space?	N/A
				Road X Slope (%)	N/A	N/A	Clear Space to XWalk (in)	N/A
			N/A	Any Obstructions?	N/A	N/A	Storm Grate/Utility Hazard?	N/A
				Obstruction Type			Storm Grate/Utility Type	
					N/A			N/A
						Yes	Surface Condition? (G/P)	Good
Total Cost:		\$ 1850.00
