Access Compliance Report

Public Rights-of-Way

(Curb Ramps)

Intersection ID: 46821	Main Street: RED_PINE_CT	Cross Street: AZALEA_HILLS_DR	Location: E
ADA ID: 17EA1BAF33F2	Ramp Type: PerpDiag	Initial Pass/Fail: Fail	Overall Compliance: No
Severity Score: 10			
Codes/Mitigation Info/Possible Solution		Field Measurements/Component Compliance

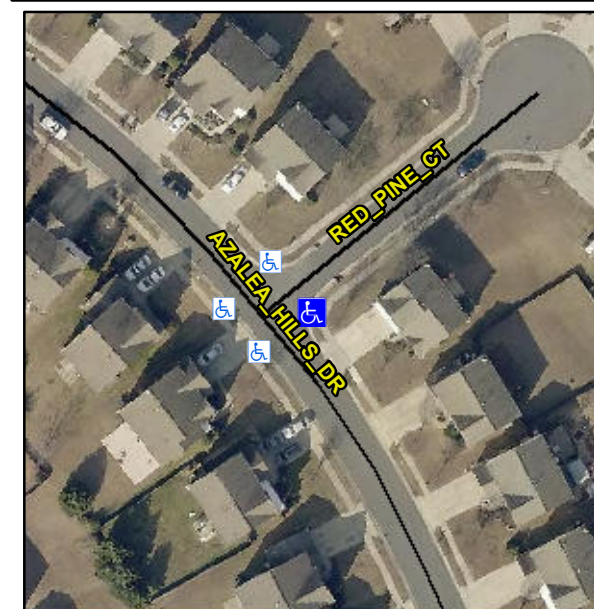
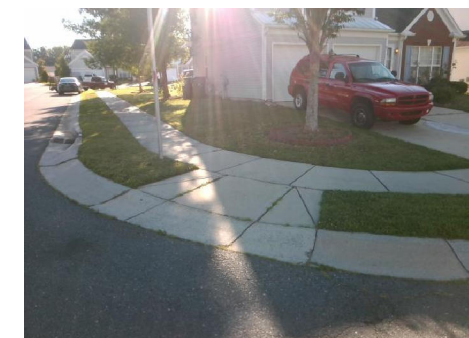
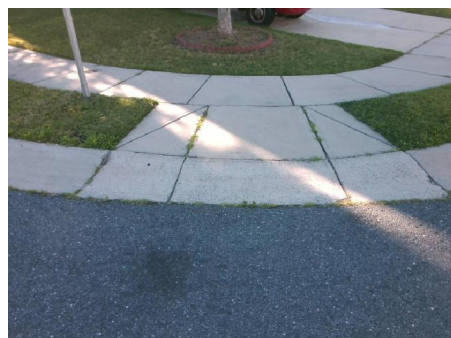
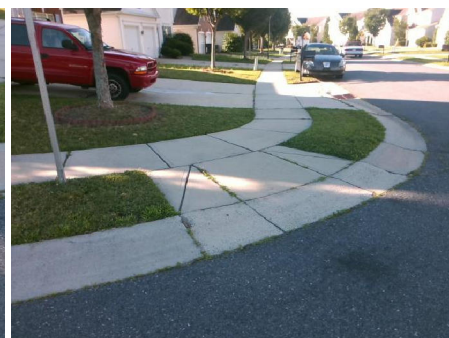
Not Found, R304.5.1, R304.5.3

Compliance	Description	Data	Compliance	Description	Data
N/A	Ramp Length (in)	47.5	Yes	Ramp Slope (%)	5.6
No	Ramp Width (in)	41.2	No	Ramp XSlope (%)	3.0
N/A	Flare Type LT	N/A	N/A	Flare Type RT	N/A
N/A	Flare Slope LT (%)	N/A	N/A	Flare Slope RT (%)	N/A
N/A	Flare Traversable LT?	N/A	N/A	Flare Traversable RT?	N/A
N/A	Landing Length (in)	N/A	N/A	DWS Provided?	N/A
N/A	Landing Width (in)	N/A	N/A	DWS Contrast?	N/A
N/A	Landing Slope (%)	N/A	N/A	DWS Length (in)	N/A
N/A	Landing X Slope (%)	N/A	N/A	DWS Full Width?	N/A
N/A	Landing Curb? (Y/N)	N/A	N/A	DWS Offset (in)	N/A
N/A	Shared Landing?	N/A			
N/A	Gutter Ponding?	N/A	N/A	Gutter Slope (%)	N/A
N/A	Gutter Lip Ht (in)	N/A	N/A	Gutter X Slope (%)	N/A
N/A	Painted X Walk1?	No	N/A	Painted X Walk2?	No
	X Walk 1 Direction	To NW		X Walk 2 Direction	To SW
N/A	X Walk 1 Width (in)	N/A	N/A	X Walk 2 Width (in)	N/A
	X Walk 1 Slope (%)	0.2		X Walk 2 Slope (%)	2.7
	X Walk 1 X Slope (%)	3.7		X Walk 2 X Slope (%)	3.0

N/A	Ramp inside XWalk1?	N/A	N/A	Ramp inside XWalk2?	N/A
	Road Slope (%)	3.0	N/A	Clear Space?	N/A
	Road X Slope (%)	0.7	N/A	Clear Space to XWalk (in)	N/A
N/A	Any Obstructions?	N/A	N/A	Storm Grate/Utility Hazard?	N/A
	Obstruction Type			Storm Grate/Utility Type	
		N/A			N/A
		Yes		Surface Condition? (G/P)	Good

Remove & Replace Curb Ramp With Two New Directional Ramps or Equivalent.
