Access Compliance Report

Public Rights-of-Way

(Curb Ramps)

Intersection ID: 10024493	Main Street: CROWNPOINT_EXECUTIVE_DR	Cross Street: N/A	Location: W
ADA ID: 17EB0E8B7387	Ramp Type: PerpDiag	Initial Pass/Fail: Fail	Overall Compliance: No
Severity Score: 8.75			
Codes/Mitigation Info/Possible Solution		Field Measurements/Component Compliance

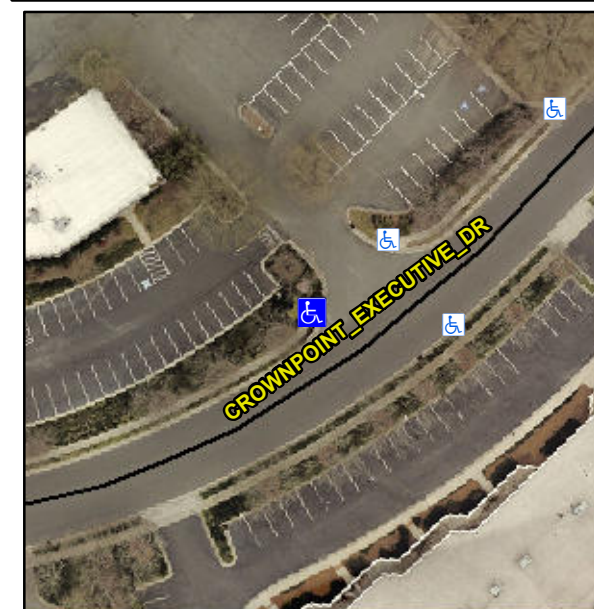
Compliance	Description	Data	Compliance	Description	Data
N/A	Ramp Length (in)	35.0	Yes	Ramp Slope (%)	6.5
No	Ramp Width (in)	46.5	Yes	Ramp XSlope (%)	0.8
N/A	Flare Type LT	N/A	N/A	Flare Type RT	N/A
N/A	Flare Slope LT (%)	N/A	N/A	Flare Slope RT (%)	N/A
N/A	Flare Traversable LT?	N/A	N/A	Flare Traversable RT?	N/A
N/A	Landing Length (in)	N/A	N/A	DWS Provided?	N/A
N/A	Landing Width (in)	N/A	N/A	DWS Contrast?	N/A
N/A	Landing Slope (%)	N/A	N/A	DWS Length (in)	N/A
N/A	Landing X Slope (%)	N/A	N/A	DWS Full Width?	N/A
N/A	Landing Curb? (Y/N)	N/A	N/A	DWS Offset (in)	N/A
N/A	Shared Landing?	N/A			
N/A	Gutter Ponding?	N/A	N/A	Gutter Slope (%)	N/A
N/A	Gutter Lip Ht (in)	N/A	N/A	Gutter X Slope (%)	N/A
N/A	Painted X Walk1?	No	N/A	Painted X Walk2?	No
	X Walk 1 Direction	To SE		X Walk 2 Direction	To NE
N/A	X Walk 1 Width (in)	N/A	N/A	X Walk 2 Width (in)	N/A
	X Walk 1 Slope (%)	3.3		X Walk 2 Slope (%)	6.4
	X Walk 1 X Slope (%)	3.1		X Walk 2 X Slope (%)	0.2

N/A	Ramp inside XWalk1?	N/A	N/A	Ramp inside XWalk2?	N/A
	Road Slope (%)	2.7	N/A	Clear Space?	N/A
	Road X Slope (%)	1.5	N/A	Clear Space to XWalk (in)	N/A
N/A	Any Obstructions?	N/A	N/A	Storm Grate/Utility Hazard?	N/A
	Obstruction Type			Storm Grate/Utility Type	
		N/A			N/A
			Yes	Surface Condition? (G/P)	Good

Possible Solutions:

Remove & Replace Curb Ramp With Two New Directional Ramps or Equivalent.
