# Access Compliance Report

## Public Rights-of-Way

### (Curb Ramps)

Intersection ID: N/A	Main Street: CALLEY_GLENN_LN	Cross Street: FIVE_KNOLLS_DR	Location: SE
ADA ID: 17F9CD425CA2	Ramp Type: PerpDiag	Initial Pass/Fail: Fail	Overall Compliance: No
Severity Score: 8.75			
Codes/Mitigation Info/Possible Solution		Field Measurements/Component Compliance

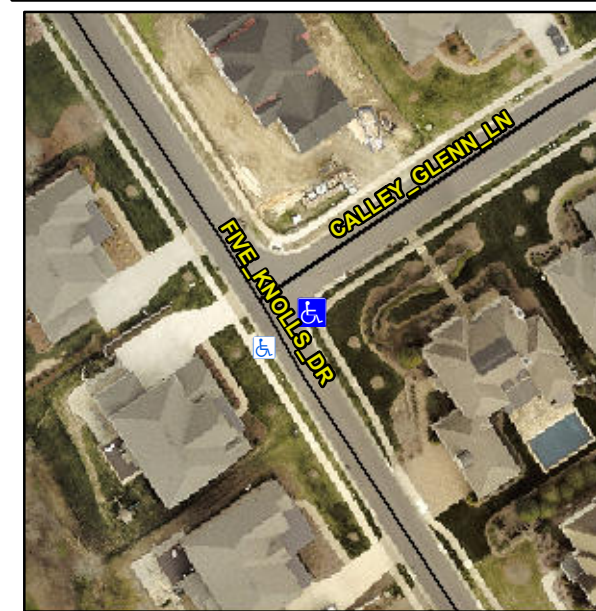
**Not Found, R304.5.1**

Compliance	Description	Data	Compliance	Description	Data
N/A	Ramp Length (in)	47.5	Yes	Ramp Slope (%)	5.0
No	Ramp Width (in)	46.0	Yes	Ramp XSlope (%)	2.0
N/A	Flare Type LT	N/A	N/A	Flare Type RT	N/A
N/A	Flare Slope LT (%)	N/A	N/A	Flare Slope RT (%)	N/A
N/A	Flare Traversable LT?	N/A	N/A	Flare Traversable RT?	N/A
N/A	Landing Length (in)	N/A	N/A	DWS Provided?	N/A
N/A	Landing Width (in)	N/A	N/A	DWS Contrast?	N/A
N/A	Landing Slope (%)	N/A	N/A	DWS Length (in)	N/A
N/A	Landing X Slope (%)	N/A	N/A	DWS Full Width?	N/A
N/A	Landing Curb? (Y/N)	N/A	N/A	DWS Offset (in)	N/A
N/A	Shared Landing?	N/A			
N/A	Gutter Ponding?	N/A	N/A	Gutter Slope (%)	N/A
N/A	Gutter Lip Ht (in)	N/A	N/A	Gutter X Slope (%)	N/A
N/A	Painted X Walk1?	No	N/A	Painted X Walk2?	No
	X Walk 1 Direction	To N		X Walk 2 Direction	To W
N/A	X Walk 1 Width (in)	N/A	N/A	X Walk 2 Width (in)	N/A
	X Walk 1 Slope (%)	1.7		X Walk 2 Slope (%)	1.8
	X Walk 1 X Slope (%)	2.2		X Walk 2 X Slope (%)	1.5

N/A	Ramp inside XWalk1?	N/A	N/A	Ramp inside XWalk2?	N/A
	Road Slope (%)	3.1	N/A	Clear Space?	N/A
	Road X Slope (%)	0.3	N/A	Clear Space to XWalk (in)	N/A
N/A	Any Obstructions?	N/A	N/A	Storm Grate/Utility Hazard?	N/A
	Obstruction Type			Storm Grate/Utility Type	
		N/A			N/A
			Yes	Surface Condition? (G/P)	Good

**Remove & Replace Curb Ramp With Two New Directional Ramps or Equivalent.**
