# Access Compliance Report

## Public Rights-of-Way

### (Curb Ramps)

Intersection ID: 5464	Main Street: OAK_DR	Cross Street: WANAMASSA_DR	Location: S
ADA ID: 17FB4A259E84	Ramp Type: Perp	Initial Pass/Fail: Fail	Overall Compliance: No
Severity Score: 22.5			
Codes/Mitigation Info/Possible Solution		Field Measurements/Component Compliance

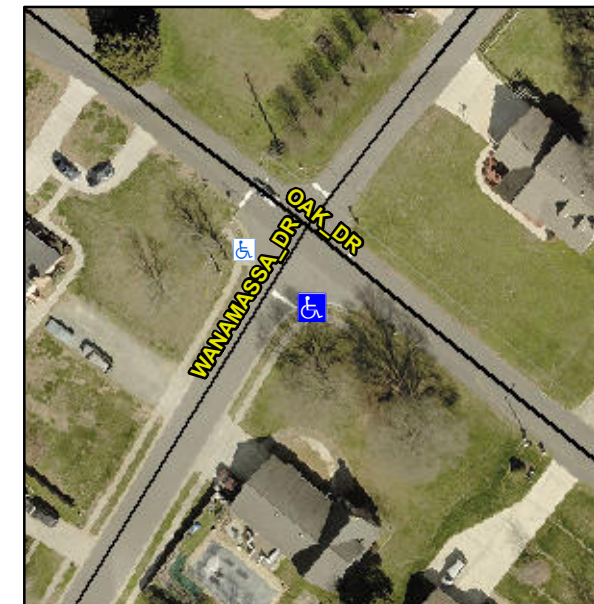
Compliance	Description	Data	Compliance	Description	Data
N/A	Ramp Length (in)	49.5	No	Ramp Slope (%)	9.8
No	Ramp Width (in)	47.0	No	Ramp XSlope (%)	2.5
N/A	Flare Type LT	N/A	N/A	Flare Type RT	N/A
N/A	Flare Slope LT (%)	N/A	N/A	Flare Slope RT (%)	N/A
N/A	Flare Traversable LT?	N/A	N/A	Flare Traversable RT?	N/A
N/A	Landing Length (in)	N/A	N/A	DWS Provided?	N/A
N/A	Landing Width (in)	N/A	N/A	DWS Contrast?	N/A
N/A	Landing Slope (%)	N/A	N/A	DWS Length (in)	N/A
N/A	Landing X Slope (%)	N/A	N/A	DWS Full Width?	N/A
N/A	Landing Curb? (Y/N)	N/A	N/A	DWS Offset (in)	N/A
N/A	Shared Landing?	N/A			
N/A	Gutter Ponding?	N/A	N/A	Gutter Slope (%)	N/A
N/A	Gutter Lip Ht (in)	N/A	N/A	Gutter X Slope (%)	N/A
N/A	Painted X Walk1?	No	N/A	Painted X Walk2?	N/A
	X Walk 1 Direction	To W		X Walk 2 Direction	N/A
N/A	X Walk 1 Width (in)	N/A	N/A	X Walk 2 Width (in)	N/A
	X Walk 1 Slope (%)	1.7		X Walk 2 Slope (%)	N/A
	X Walk 1 X Slope (%)	1.1		X Walk 2 X Slope (%)	N/A

N/A	Ramp inside XWalk1?	N/A	N/A	Ramp inside XWalk2?	N/A
	Road Slope (%)	N/A	N/A	Clear Space?	N/A
	Road X Slope (%)	N/A	N/A	Clear Space to XWalk (in)	N/A
N/A	Any Obstructions?	N/A	N/A	Storm Grate/Utility Hazard?	N/A
	Obstruction Type			Storm Grate/Utility Type	
		N/A			N/A
			Yes	Surface Condition? (G/P)	Good

Possible Solutions:

**Remove & Replace Entire Ramp.**

**R304.5.1, R304.2.2, R304.5.3**
