Access Compliance Report

Public Rights-of-Way (Curb Ramps)

Intersection ID: 10020966	Main Street: BENSEVAL_LN	Cross Street: N/A	Location:	E
ADA ID: 17FF4636EECF	Ramp Type: BlendTrans1	Initial Pass/Fail: Fail	Overall Compliance: No	Severity Score: 10

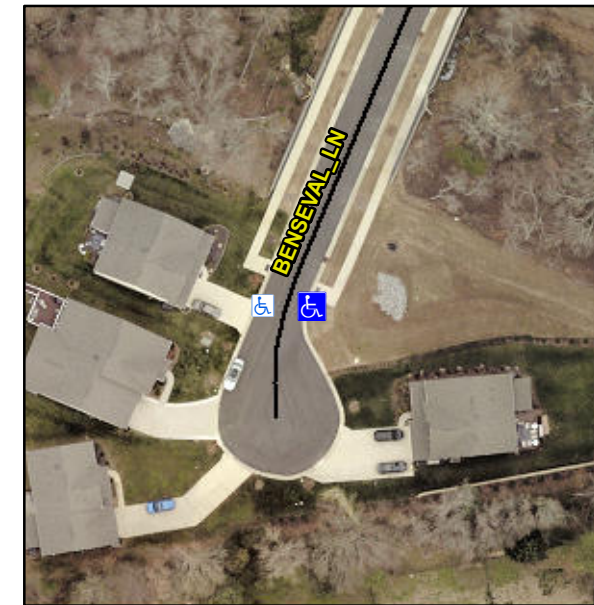
Not Found, R304.5.1, R304.5.3

Compliance	Description	Data	Compliance	Description	Data
N/A	Ramp Length (in)	97.0	Yes	BlendTrans Slope (%)	3.8
No	Ramp Width (in)	47.5	No	BlendTrans XSlope (%)	2.4
N/A	Flare Type LT	N/A	N/A	Flare Type RT	N/A
N/A	Flare Slope LT (%)	N/A	N/A	Flare Slope RT (%)	N/A
N/A	Flare Traversable LT?	N/A	N/A	Flare Traversable RT?	N/A
N/A	Landing Length (in)	N/A	N/A	DWS Provided?	N/A
N/A	Landing Width (in)	N/A	N/A	DWS Contrast?	N/A
N/A	Landing Slope (%)	N/A	N/A	DWS Length (in)	N/A
N/A	Landing X Slope (%)	N/A	N/A	DWS Full Width?	N/A
N/A	Landing Curb? (Y/N)	N/A	N/A	DWS Offset (in)	N/A
N/A	Shared Landing?	N/A			
N/A	Gutter Ponding?	N/A	N/A	Gutter Slope (%)	N/A
N/A	Gutter Lip Ht (in)	N/A	N/A	Gutter X Slope (%)	N/A
N/A	Painted X Walk1?	No	N/A	Painted X Walk2?	N/A
	X Walk 1 Direction	To W		X Walk 2 Direction	N/A
	X Walk 1 Width (in)	N/A		X Walk 2 Width (in)	N/A
	X Walk 1 Slope (%)	3.8		X Walk 2 Slope (%)	N/A
	X Walk 1 X Slope (%)	2.2		X Walk 2 X Slope (%)	N/A

N/A	Ramp inside XWalk1?	N/A	N/A	Ramp inside XWalk2?	N/A
	Road Slope (%)	2.2		Clear Space?	N/A
	Road X Slope (%)	3.8	N/A	Clear Space to XWalk (in)	N/A
N/A	Any Obstructions?	N/A	N/A	Storm Grate/Utility Hazard?	N/A
	Obstruction Type			Storm Grate/Utility Type	
		N/A			N/A
			Yes	Surface Condition? (G/P)	Good
			No	Curb Slope (%)	6.6

Remove & Replace Curb Ramp With Two New Directional Ramps or Equivalent.
