Access Compliance Report

Public Rights-of-Way (Curb Ramps)

Intersection ID: 14711	Main Street: VAIL_AV	Cross Street: VAN_NESS_ST	Location: SE
ADA ID: 180A807A16C9	Ramp Type: Directional1	Initial Pass/Fail: Fail	Overall Compliance: No
		Severity Score: 10

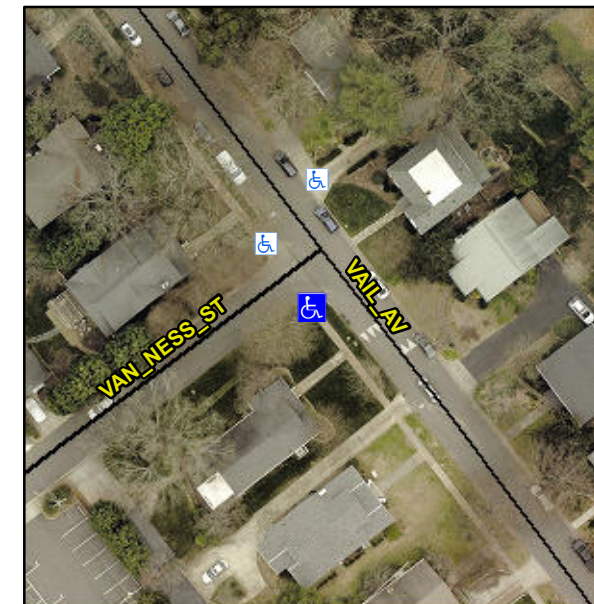
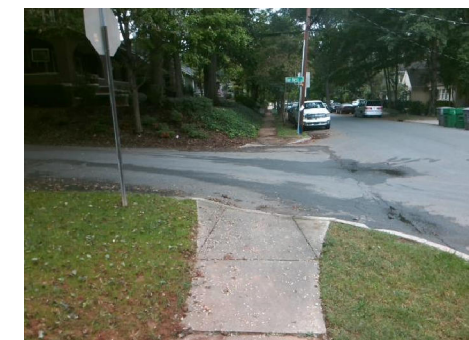
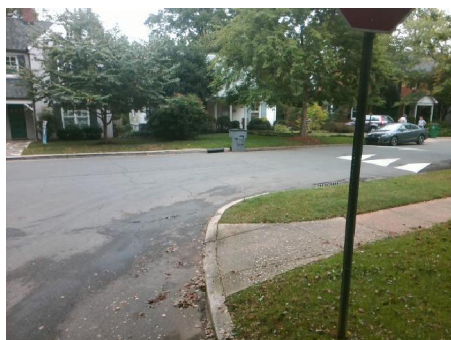
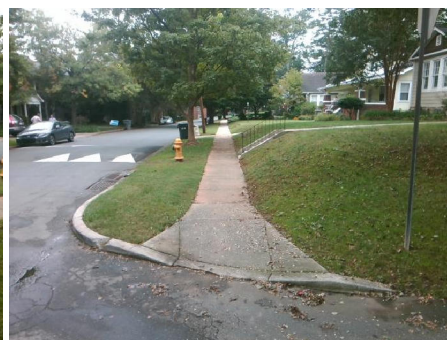
R304.5.1, R304.5.3

Compliance	Description	Data	Compliance	Description	Data
N/A	Ramp Length (in)	70.0	N/A	Grade Break?	N/A
No	Ramp Width (in)	45.0	N/A	Grade Break Slope (%)	0.0
Yes	Ramp Slope (%)	6.0	N/A	Grade Break XSlope (%)	0.0
No	Ramp XSlope (%)	4.7			
N/A	Flare Type LT	N/A	N/A	Flare Type RT	N/A
N/A	Flare Slope LT (%)	N/A	N/A	Flare Slope RT (%)	0.0
N/A	Flare Traversable LT?	N/A	N/A	Flare Traversable RT?	N/A
N/A	Landing Length (in)	0.0	N/A	DWS Provided?	N/A
N/A	Landing Width (in)	0.0	N/A	DWS Contrast?	N/A
N/A	Landing Slope (%)	0.0	N/A	DWS Length (in)	N/A
N/A	Landing X Slope (%)	0.0	N/A	DWS Full Width?	N/A
N/A	Landing Curb? (Y/N)	N/A	N/A	DWS Offset LT (in)	N/A
N/A	Shared Landing?	N/A	N/A	DWS Offset RT (in)	N/A
N/A	Gutter Ponding?	0.0	N/A	Gutter Slope (%)	N/A
N/A	Gutter Lip Ht (in)	0.0	N/A	Gutter X Slope (%)	N/A
N/A	Painted X Walk1?	No		Road Slope (%)	2.8
	X Walk 1 Direction	To NW		Road X Slope (%)	7.7
	X Walk 1 Width (in)	N/A		Clear Space?	N/A

X Walk 1 Slope (%)	2.8	N/A	Clear Space to XWalk (in)	N/A
	X Walk 1 X Slope (%)	7.7	N/A	Storm Grate/Utility Hazard?	N/A
N/A	Ramp inside XWalk1?	N/A		Storm Grate/Utility Type	
N/A	Any Obstructions?	N/A			N/A
	Obstruction Type		Yes	Surface Condition? (G/P)	Good
			N/A	Curb Slope (%)	15.9

Remove & Replace Entire Ramp.
