# Access Compliance Report

## Public Rights-of-Way

### (Curb Ramps)

Intersection ID: N/A	Main Street: TRYON_ST	Cross Street: CRESCENT_SPRINGS_DR	Location: SW
ADA ID: 181B4BA5D7B9	Ramp Type: PerpDiag	Initial Pass/Fail: Fail	Overall Compliance: No
			Severity Score: 10

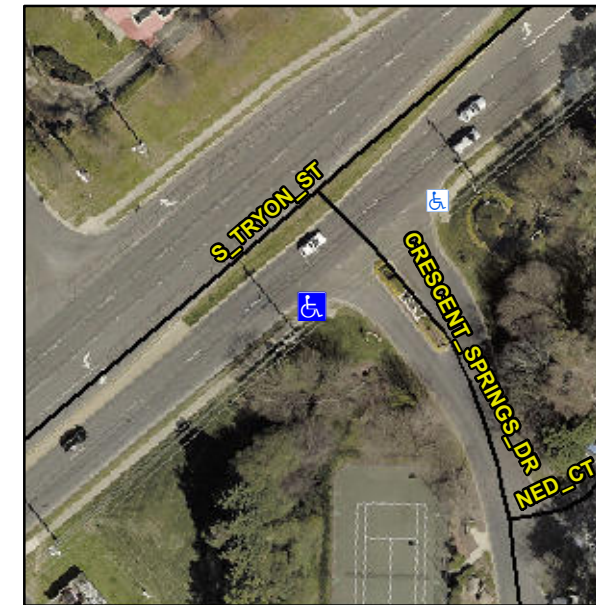
**Not Found, R304.5.1, R304.5.3**

Compliance	Description	Data	Compliance	Description	Data
N/A	Ramp Length (in)	48.0	Yes	Ramp Slope (%)	6.7
No	Ramp Width (in)	44.0	No	Ramp XSlope (%)	4.4
N/A	Flare Type LT	N/A	N/A	Flare Type RT	N/A
N/A	Flare Slope LT (%)	N/A	N/A	Flare Slope RT (%)	N/A
N/A	Flare Traversable LT?	N/A	N/A	Flare Traversable RT?	N/A
N/A	Landing Length (in)	N/A	N/A	DWS Provided?	N/A
N/A	Landing Width (in)	N/A	N/A	DWS Contrast?	N/A
N/A	Landing Slope (%)	N/A	N/A	DWS Length (in)	N/A
N/A	Landing X Slope (%)	N/A	N/A	DWS Full Width?	N/A
N/A	Landing Curb? (Y/N)	N/A	N/A	DWS Offset (in)	N/A
N/A	Shared Landing?	N/A			
N/A	Gutter Ponding?	N/A	N/A	Gutter Slope (%)	N/A
N/A	Gutter Lip Ht (in)	N/A	N/A	Gutter X Slope (%)	N/A
N/A	Painted X Walk1?	No	N/A	Painted X Walk2?	No
	X Walk 1 Direction	To NE		X Walk 2 Direction	To NW
N/A	X Walk 1 Width (in)	N/A	N/A	X Walk 2 Width (in)	N/A
	X Walk 1 Slope (%)	2.3		X Walk 2 Slope (%)	2.4
	X Walk 1 X Slope (%)	0.7		X Walk 2 X Slope (%)	2.7

N/A	Ramp inside XWalk1?	N/A	N/A	Ramp inside XWalk2?	N/A
	Road Slope (%)	2.4	N/A	Clear Space?	N/A
	Road X Slope (%)	0.4	N/A	Clear Space to XWalk (in)	N/A
N/A	Any Obstructions?	N/A	N/A	Storm Grate/Utility Hazard?	N/A
	Obstruction Type			Storm Grate/Utility Type	
		N/A			N/A
			Yes	Surface Condition? (G/P)	Good

**Remove & Replace Curb Ramp With Two New Directional Ramps or Equivalent.**
