# Access Compliance Report

## Public Rights-of-Way

| Intersection ID: 48949 | Main Street: OLD_STONE_CROSSING_DR | Cross Street: DAVID_JENNINGS_AV | Location: SW |
| ADA ID: 18298A18B212 | Ramp Type: BlendTrans1 | Initial Pass/Fail: Fail | Overall Compliance: No |

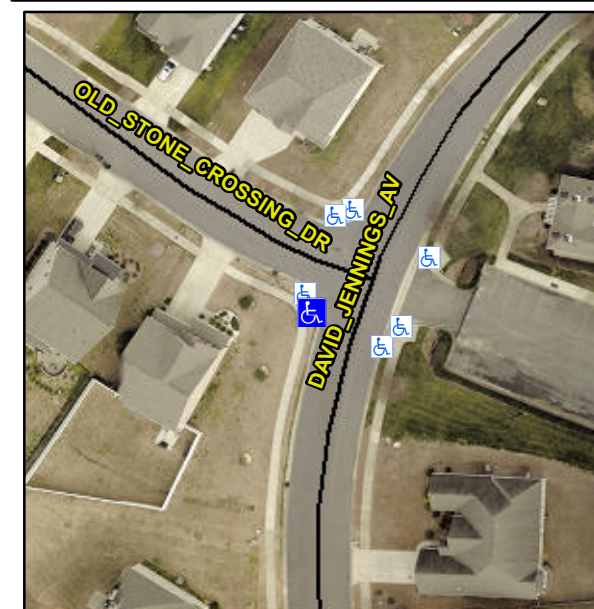
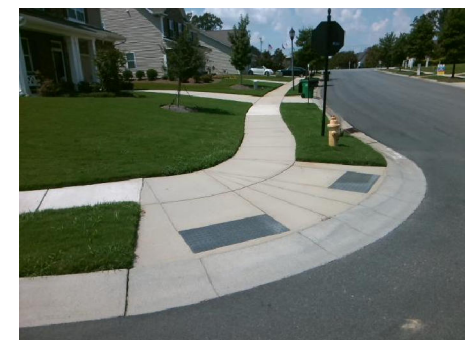
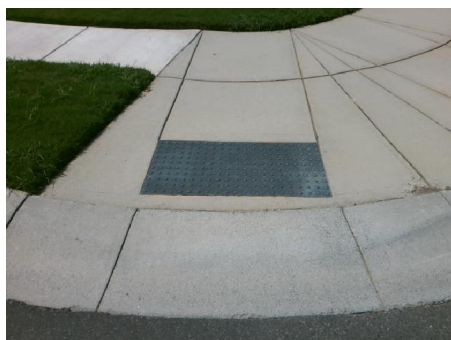
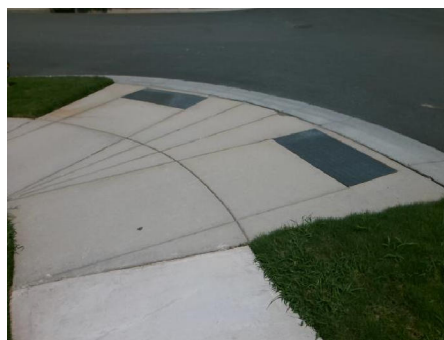
**RT FL LIP 1.0**

**Not Found, R304.5.1**

| Compliance | Description | Data | Compliance | Description | Data |
|---|---|---|---|---|---|
| No | Ramp Width (in) | 47.0 | Yes | BlendTrans XSlope (%) | 1.5 |
| | | | No | Curb Slope (%) | 19.8 |

**Remove & Replace Curb Ramp With Two New Directional Ramps or Equivalent.**

Total Cost: \$ 3200.00
