Access Compliance Report

Public Rights-of-Way

(Curb Ramps)

Intersection ID: 47231	Main Street: ROMANY_RD	Cross Street: MOREHEAD_MEDICAL_DR	Location: SW
ADA ID: 1832060FAC15	Ramp Type: PerpDiag	Initial Pass/Fail: Fail	Overall Compliance: No
		Severity Score: 58.75

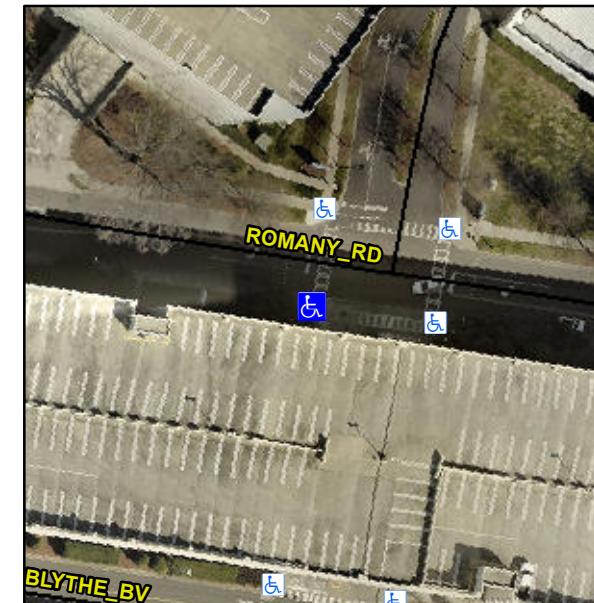
Compliance	Description	Data	Compliance	Description	Data
N/A	Ramp Length (in)	48.0	No	Ramp Slope (%)	15.6
No	Ramp Width (in)	39.0	No	Ramp XSlope (%)	9.9
N/A	Flare Type LT	N/A	N/A	Flare Type RT	N/A
N/A	Flare Slope LT (%)	N/A	N/A	Flare Slope RT (%)	N/A
N/A	Flare Traversable LT?	N/A	N/A	Flare Traversable RT?	N/A
N/A	Landing Length (in)	N/A	N/A	DWS Provided?	N/A
N/A	Landing Width (in)	N/A	N/A	DWS Contrast?	N/A
N/A	Landing Slope (%)	N/A	N/A	DWS Length (in)	N/A
N/A	Landing X Slope (%)	N/A	N/A	DWS Full Width?	N/A
N/A	Landing Curb? (Y/N)	N/A	N/A	DWS Offset (in)	N/A
N/A	Shared Landing?	N/A			
N/A	Gutter Ponding?	N/A	N/A	Gutter Slope (%)	N/A
N/A	Gutter Lip Ht (in)	N/A	N/A	Gutter X Slope (%)	N/A
N/A	Painted X Walk1?	Yes	N/A	Painted X Walk2?	Yes
	X Walk 1 Direction	To E		X Walk 2 Direction	To N
N/A	X Walk 1 Width (in)	60.0	N/A	X Walk 2 Width (in)	60.0
	X Walk 1 Slope (%)	3.9		X Walk 2 Slope (%)	12.9
	X Walk 1 X Slope (%)	7.8		X Walk 2 X Slope (%)	13.2

N/A	Ramp inside XWalk1?	Yes	N/A	Ramp inside XWalk2?	Yes
	Road Slope (%)	4.6	N/A	Clear Space?	N/A
	Road X Slope (%)	8.0	N/A	Clear Space to XWalk (in)	N/A
N/A	Any Obstructions?	N/A	N/A	Storm Grate/Utility Hazard?	N/A
	Obstruction Type			Storm Grate/Utility Type	
		N/A			N/A
		Yes		Surface Condition? (G/P)	Good

Remove & Replace Curb Ramp With Two New Directional Ramps or Equivalent.
