Access Compliance Report Public Rights-of-Way (Curb Ramps)

Intersection ID: 10031810 Main Street: MILLENNIUM_AV Cross Street: N/A Location: S

ADA ID: 184021263566 Ramp Type: Perp Initial Pass/Fail: Fail Overall Compliance: No Severity Score: 12.5

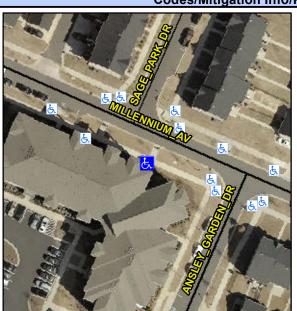
Field Measurements/Component Compliance							
Compliance Description Dat			Comp	liance Description	Data		
N/A	Ramp Length (in)	161.0	No	Ramp Slope (%)	8.6		
Yes	Ramp Width (in)	72.0	Yes	Ramp XSlope (%)	1.1		
N/A	Flare Type LT	N/A	N/A	Flare Type RT	N/A		
N/A	Flare Slope LT (%)	N/A	N/A	Flare Slope RT (%)	N/A		
N/A	Flare Traversable LT?	N/A	N/A	Flare Traversable RT?	N/A		
N/A	Landing Length (in)	N/A	N/A	DWS Provided?	N/A		
N/A	Landing Width (in)	N/A	N/A	DWS Contrast?	N/A		
N/A	Landing Slope (%)	N/A	N/A	DWS Length (in)	N/A		
N/A	Landing X Slope (%)	N/A	N/A	DWS Full Width?	N/A		
N/A	Landing Curb? (Y/N)	N/A	N/A	DWS Offset (in)	N/A		
N/A	Shared Landing?	N/A					
N/A	Gutter Ponding?	N/A	N/A	Gutter Slope (%)	N/A		
N/A	Gutter Lip Ht (in)	N/A	N/A	Gutter X Slope (%)	N/A		
N/A	Painted X Walk1?	No	N/A	Painted X Walk2?	N/A		
	X Walk 1 Direction	To NE		X Walk 2 Direction	N/A		
N/A	X Walk 1 Width (in)	N/A	N/A	X Walk 2 Width (in)	N/A

200	Possible Solutions:	<u>c</u>
No.	Remove & Replace Entire Ramp.	N
ű		Υ
Q (a)		N
Š		N
q		N
		N
100	Surveyor Notes:	N
100	N/A	N
1		N
0.000		N
		N
ĺ	PROW/ADA:	N
	R304.2.2	N
100		N
CAN.		
į		N
		N
