# Access Compliance Report

## Public Rights-of-Way

### (Curb Ramps)

Intersection ID: 31418	Main Street: CHEVIOTT_HILL_LN	Cross Street: GUILDHALL_LN	Location: NW
ADA ID: 18418C8E0DCC	Ramp Type: PerpDiag	Initial Pass/Fail: Fail	Overall Compliance: No
Severity Score: 8.75			
Codes/Mitigation Info/Possible Solution		Field Measurements/Component Compliance

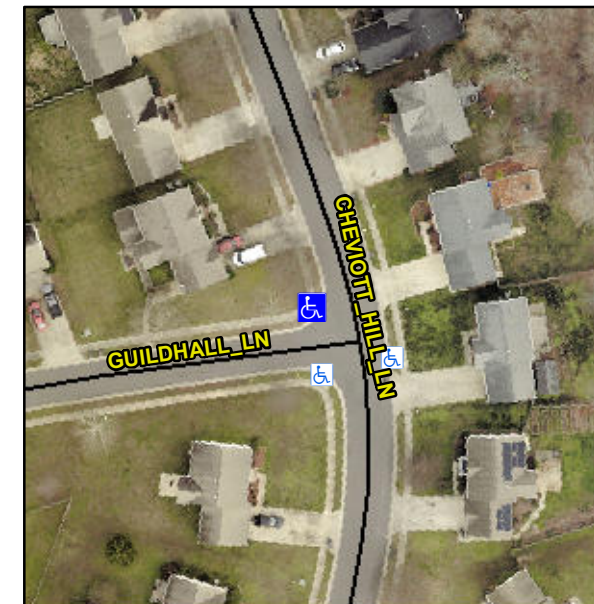
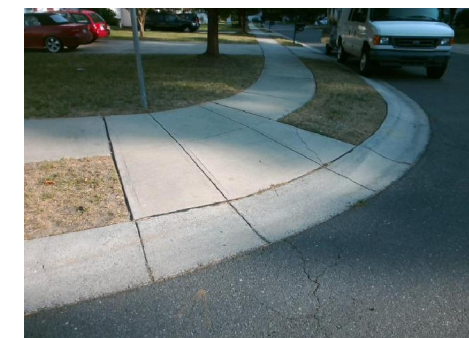
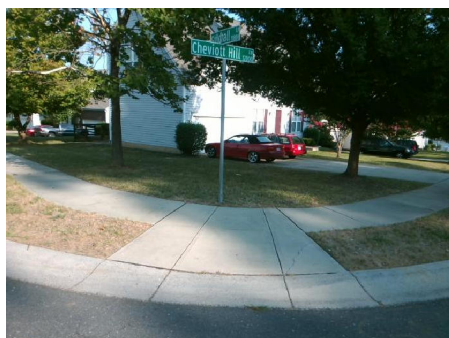
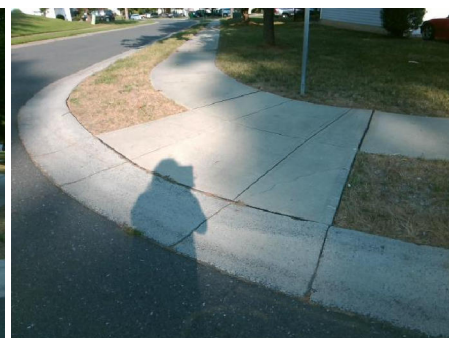
Compliance	Description	Data	Compliance	Description	Data
N/A	Ramp Length (in)	50.0	Yes	Ramp Slope (%)	7.4
No	Ramp Width (in)	39.0	Yes	Ramp XSlope (%)	1.5
N/A	Flare Type LT	N/A	N/A	Flare Type RT	N/A
N/A	Flare Slope LT (%)	N/A	N/A	Flare Slope RT (%)	N/A
N/A	Flare Traversable LT?	N/A	N/A	Flare Traversable RT?	N/A
N/A	Landing Length (in)	N/A	N/A	DWS Provided?	N/A
N/A	Landing Width (in)	N/A	N/A	DWS Contrast?	N/A
N/A	Landing Slope (%)	N/A	N/A	DWS Length (in)	N/A
N/A	Landing X Slope (%)	N/A	N/A	DWS Full Width?	N/A
N/A	Landing Curb? (Y/N)	N/A	N/A	DWS Offset (in)	N/A
N/A	Shared Landing?	N/A			
N/A	Gutter Ponding?	N/A	N/A	Gutter Slope (%)	N/A
N/A	Gutter Lip Ht (in)	N/A	N/A	Gutter X Slope (%)	N/A
N/A	Painted X Walk1?	No	N/A	Painted X Walk2?	No
	X Walk 1 Direction	To S		X Walk 2 Direction	To E
N/A	X Walk 1 Width (in)	N/A	N/A	X Walk 2 Width (in)	N/A
	X Walk 1 Slope (%)	5.9		X Walk 2 Slope (%)	5.8
	X Walk 1 X Slope (%)	2.8		X Walk 2 X Slope (%)	8.4

N/A	Ramp inside XWalk1?	N/A	N/A	Ramp inside XWalk2?	N/A
	Road Slope (%)	3.1	N/A	Clear Space?	N/A
	Road X Slope (%)	7.1	N/A	Clear Space to XWalk (in)	N/A
N/A	Any Obstructions?	N/A	N/A	Storm Grate/Utility Hazard?	N/A
	Obstruction Type			Storm Grate/Utility Type	
		N/A			N/A
		Yes		Surface Condition? (G/P)	Good

**Remove & Replace Curb Ramp With Two New Directional Ramps or Equivalent.**

**Not Found, R304.5.1**
