Access Compliance Report Public Rights-of-Way (Curb Ramps)

Intersection ID: 29793 Main Street: BRISTLE TOE LN Cross Street: DESTIN_LN Location: NE ADA ID: 18441342F277 Ramp Type: PerpDiag Initial Pass/Fail: Fail **Overall Compliance: No Severity Score:** 12.5

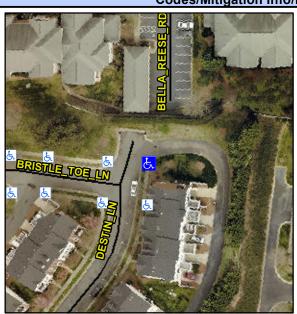
| Field Measurements/Component Compliance | | | | | | |
|---|---|---|---|---|---|---|
| N/A | Ramp Length (in) | 94.0 | No | Ram | Slope (%) | 8.9 |

Possible Solutions: Remove & Replace Curb Ramp With **Two New Directional Ramps or** Equivalent. Surveyor Notes: N/A PROW/ADA: Not Found, R304.2.2
