Access Compliance Report

Public Rights-of-Way

(Curb Ramps)

Intersection ID: 12344	Main Street: REMOUNT_RD	Cross Street: GREENLAND_AV	Location: SW
ADA ID: 184CB0EAFE94	Ramp Type: Perp	Initial Pass/Fail: Fail	Overall Compliance: No
		Severity Score: 10

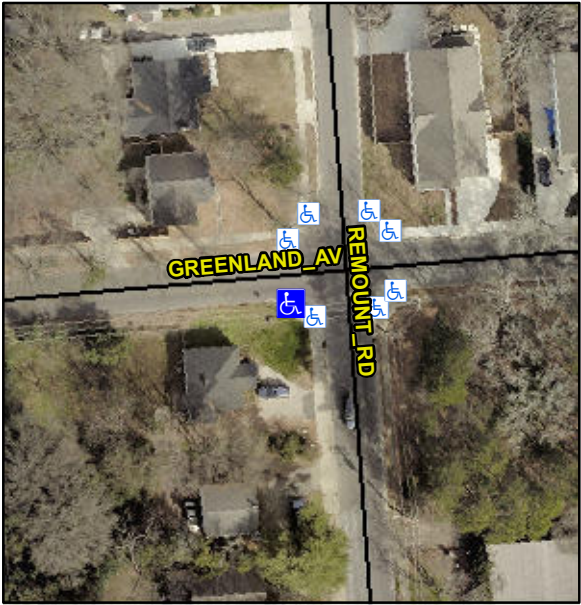
Possible Solutions:		Compliance	Description	Data	
	Remove & Replace Entire Ramp.		N/A	Ramp Length (in)	67.0	Yes
			No	Ramp Width (in)	47.5	No
			N/A	Flare Type LT	N/A	N/A
			N/A	Flare Slope LT (%)	N/A	N/A
			N/A	Flare Traversable LT?	N/A	N/A
			N/A	Landing Length (in)	N/A	N/A
			N/A	Landing Width (in)	N/A	N/A
			N/A	Landing Slope (%)	N/A	N/A
			N/A	Landing X Slope (%)	N/A	N/A
<p>Surveyor Notes:</p> <p>N/A</p> <p>PROW/ADA:</p> <p>Not Found, R304.5.1, R304.5.3</p>			N/A	Flare Type RT	N/A	N/A
			N/A	Flare Slope RT (%)	N/A	N/A
			N/A	Flare Traversable RT?	N/A	N/A
			N/A	DWS Provided?	N/A	N/A
			N/A	DWS Contrast?	N/A	N/A
			N/A	DWS Length (in)	N/A	N/A
			N/A	DWS Full Width?	N/A	N/A
			N/A	DWS Offset (in)	N/A	N/A
			N/A	Gutter Ponding?	N/A	N/A
			N/A	Gutter Lip Ht (in)	N/A	N/A
<p>Street 1 Name</p> <p>Stop Condition-Street 2</p> <p>Street 2 Name</p> <p>Stop Condition-Street 1</p>			N/A	Painted X Walk1?	No	N/A

N/A	X Walk 1 Direction	To N	N/A
			N/A	X Walk 1 Width (in)	N/A	N/A
			N/A	X Walk 1 Slope (%)	0.6	N/A
			N/A	X Walk 1 X Slope (%)	1.5	N/A
			N/A	Ramp inside XWalk1?	N/A	N/A
			N/A	Road Slope (%)	N/A	N/A
			N/A	Road X Slope (%)	N/A	N/A
			N/A	Any Obstructions?	N/A	N/A
			N/A	Obstruction Type		N/A
Total Cost:		\$ 1850.00				N/A
			N/A			N/A
			Yes	Surface Condition? (G/P)		Good
