Access Compliance Report

Public Rights-of-Way

(Curb Ramps)

Intersection ID: 31895	Main Street: SLALOM_HILL_RD	Cross Street: STOWE_DERBY_DR	Location: SE
ADA ID: 18642F4842A1	Ramp Type: PerpDiag	Initial Pass/Fail: Fail	Overall Compliance: No
Severity Score: 33.75			
Codes/Mitigation Info/Possible Solution		Field Measurements/Component Compliance

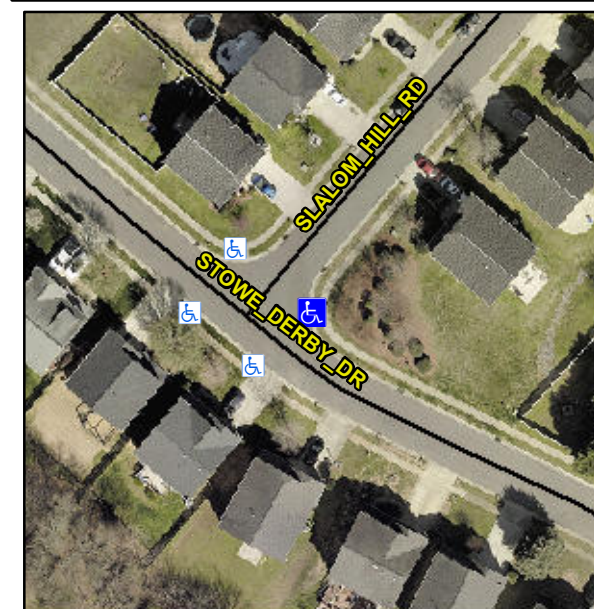
Compliance	Description	Data	Compliance	Description	Data
N/A	Ramp Length (in)	48.0	No	Ramp Slope (%)	8.5
No	Ramp Width (in)	39.0	No	Ramp XSlope (%)	5.6
N/A	Flare Type LT	N/A	N/A	Flare Type RT	N/A
N/A	Flare Slope LT (%)	N/A	N/A	Flare Slope RT (%)	N/A
N/A	Flare Traversable LT?	N/A	N/A	Flare Traversable RT?	N/A
N/A	Landing Length (in)	N/A	N/A	DWS Provided?	N/A
N/A	Landing Width (in)	N/A	N/A	DWS Contrast?	N/A
N/A	Landing Slope (%)	N/A	N/A	DWS Length (in)	N/A
N/A	Landing X Slope (%)	N/A	N/A	DWS Full Width?	N/A
N/A	Landing Curb? (Y/N)	N/A	N/A	DWS Offset (in)	N/A
N/A	Shared Landing?	N/A			
N/A	Gutter Ponding?	N/A	N/A	Gutter Slope (%)	N/A
N/A	Gutter Lip Ht (in)	N/A	N/A	Gutter X Slope (%)	N/A
N/A	Painted X Walk1?	No	N/A	Painted X Walk2?	No
	X Walk 1 Direction	To NW		X Walk 2 Direction	To SW
N/A	X Walk 1 Width (in)	N/A	N/A	X Walk 2 Width (in)	N/A
	X Walk 1 Slope (%)	0.4		X Walk 2 Slope (%)	3.0
	X Walk 1 X Slope (%)	5.1		X Walk 2 X Slope (%)	1.7

N/A	Ramp inside XWalk1?	N/A	N/A	Ramp inside XWalk2?	N/A
	Road Slope (%)	4.1	N/A	Clear Space?	N/A
	Road X Slope (%)	2.4	N/A	Clear Space to XWalk (in)	N/A
N/A	Any Obstructions?	N/A	N/A	Storm Grate/Utility Hazard?	N/A
	Obstruction Type			Storm Grate/Utility Type	
		N/A			N/A
			Yes	Surface Condition? (G/P)	Good

Possible Solutions:

Remove & Replace Curb Ramp With Two New Directional Ramps or Equivalent.
