Access Compliance Report

Public Rights-of-Way

(Curb Ramps)

Intersection ID: 6371	Main Street: CENTURY_OAKS_LN	Cross Street: STONEY_CREEK_LN	Location: E
ADA ID: 1867A5046F41	Ramp Type: BlendTrans1	Initial Pass/Fail: Fail	Overall Compliance: No
		Severity Score: 10

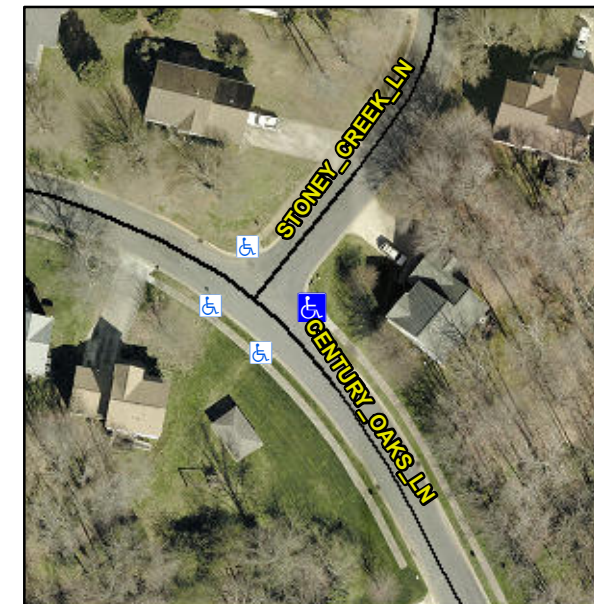
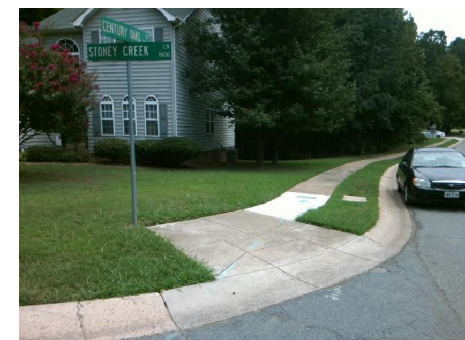
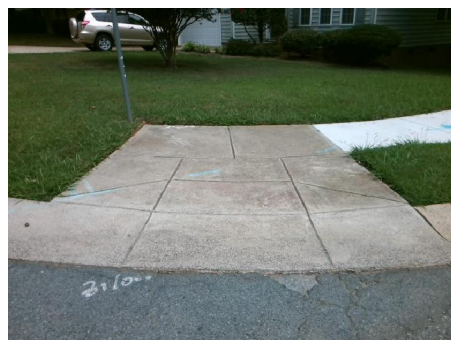
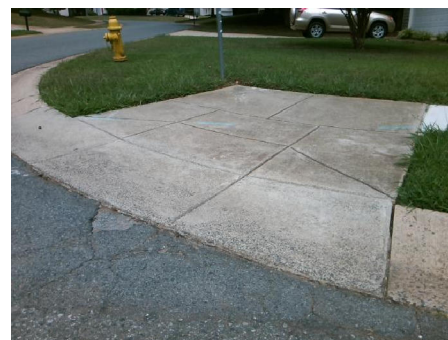
Not Found, R304.5.1, R304.5.3

Compliance	Description	Data	Compliance	Description	Data
N/A	Ramp Length (in)	44.0	Yes	BlendTrans Slope (%)	3.1
No	Ramp Width (in)	41.0	No	BlendTrans XSlope (%)	4.0
N/A	Flare Type LT	N/A	N/A	Flare Type RT	N/A
N/A	Flare Slope LT (%)	N/A	N/A	Flare Slope RT (%)	N/A
N/A	Flare Traversable LT?	N/A	N/A	Flare Traversable RT?	N/A
N/A	Landing Length (in)	N/A	N/A	DWS Provided?	N/A
N/A	Landing Width (in)	N/A	N/A	DWS Contrast?	N/A
N/A	Landing Slope (%)	N/A	N/A	DWS Length (in)	N/A
N/A	Landing X Slope (%)	N/A	N/A	DWS Full Width?	N/A
N/A	Landing Curb? (Y/N)	N/A	N/A	DWS Offset (in)	N/A
N/A	Shared Landing?	N/A			
N/A	Gutter Ponding?	N/A	N/A	Gutter Slope (%)	N/A
N/A	Gutter Lip Ht (in)	1.0	N/A	Gutter X Slope (%)	N/A
N/A	Painted X Walk1?	No	N/A	Painted X Walk2?	No
	X Walk 1 Direction	To NW		X Walk 2 Direction	To SE
	X Walk 1 Width (in)	N/A		X Walk 2 Width (in)	N/A
	X Walk 1 Slope (%)	5.7		X Walk 2 Slope (%)	1.3
	X Walk 1 X Slope (%)	1.9		X Walk 2 X Slope (%)	3.2

N/A	Ramp inside XWalk1?	N/A	N/A	Ramp inside XWalk2?	N/A
	Road Slope (%)	3.6		Clear Space?	N/A
	Road X Slope (%)	0.7	N/A	Clear Space to XWalk (in)	N/A
N/A	Any Obstructions?	N/A	N/A	Storm Grate/Utility Hazard?	N/A
	Obstruction Type			Storm Grate/Utility Type	
		N/A			N/A
			Yes	Surface Condition? (G/P)	Good
			No	Curb Slope (%)	10.7

Remove & Replace Curb Ramp With Two New Directional Ramps or Equivalent.
