# Access Compliance Report

## Public Rights-of-Way

### (Curb Ramps)

| Intersection ID: 13809 | Main Street: CHESTERFIELD_AV | Cross Street: ST_JULIEN_ST | Location: S |

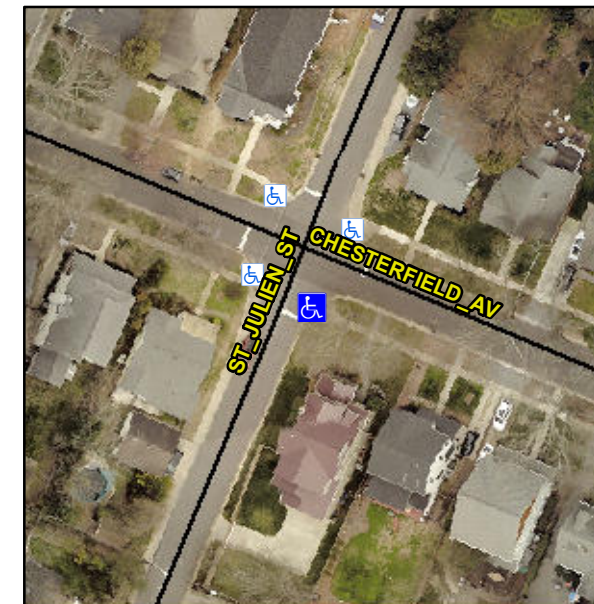
| ADA ID: 1873D5B99444 | Ramp Type: PerpDiag | Initial Pass/Fail: Fail | Overall Compliance: No |

**Not Found, R304.5.1, R304.2.2, R304.5.3**

| Compliance | Description | Data | Compliance | Description | Data |
|---|---|---|---|---|---|
| N/A | Ramp Length (in) | 49.0 | No | Ramp Slope (%) | 8.6 |
| No | Ramp Width (in) | 38.0 | No | Ramp XSlope (%) | 2.9 |

**Remove & Replace Curb Ramp With Two New Directional Ramps or Equivalent.**

Total Cost: \$ 3200.00
