# Access Compliance Report

## Public Rights-of-Way

### (Curb Ramps)

| Intersection ID: 10025885 | Main Street: ELIZABETH_AV | Cross Street: N/A | Location: S |

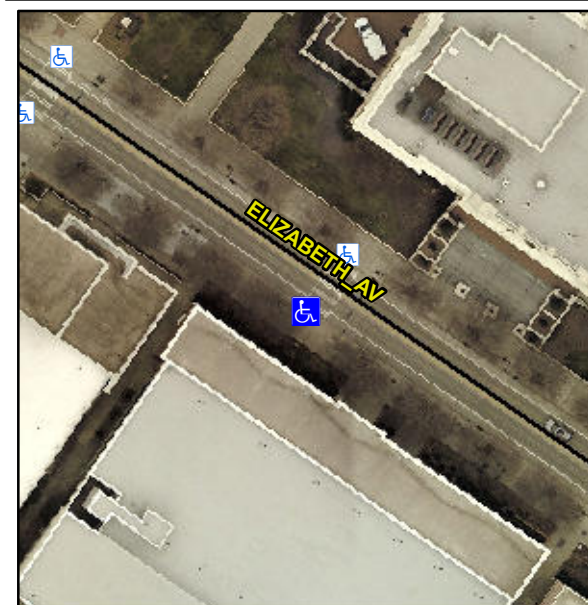
**Not Found, R304.5.3**

| Compliance | Description | Data | Compliance | Description | Data |
|---|---|---|---|---|---|
| Yes | Ramp Width (in) | 96.5 | No | Ramp XSlope (%) | 4.0 |
| No | Landing X Slope (%) | 4.0 | Yes | DWS Full Width? | Yes |
| Yes | Gutter Lip Ht (in) | 0.0 | No | Gutter X Slope (%) | 3.8 |

**Remove & Replace Entire Ramp.**  
**Remove & Replace Gutter.**

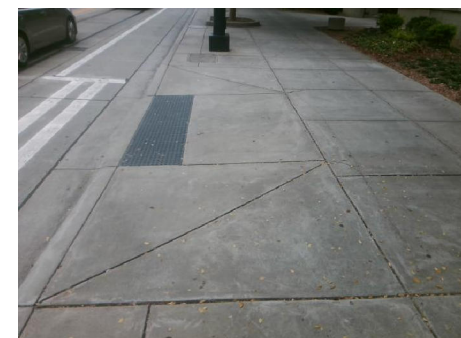
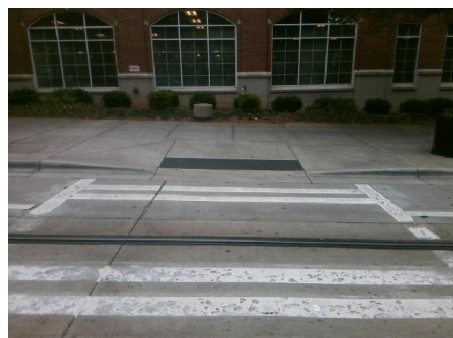
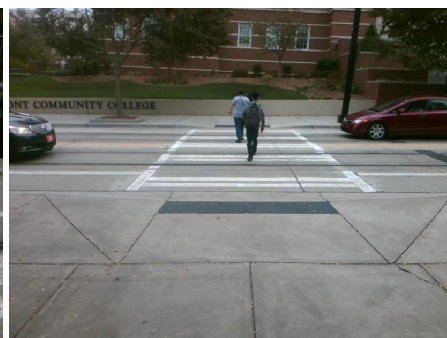
| Compliance | Description | Data | Compliance | Description | Data |
|---|---|---|---|---|---|
| | | | Yes | Surface Condition? (G/P) | Good |
