# Access Compliance Report

## Public Rights-of-Way

### (Curb Ramps)

Intersection ID: 10034400	Main Street: PIEDMONT_PARK_DR	Cross Street: AUDUBON_PARK_DR	Location:	N
ADA ID: 187FDF3A75ED	Ramp Type: Directional1	Initial Pass/Fail: Fail	Overall Compliance: No	Severity Score: 1.25

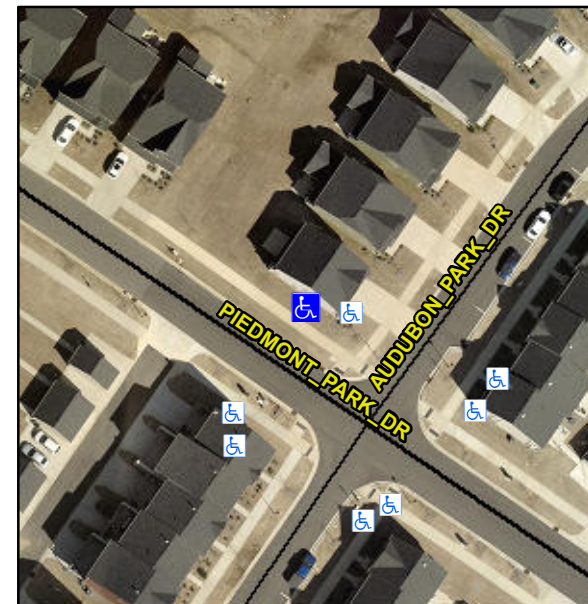
Compliance	Description	Data	Compliance	Description	Data
N/A	Ramp Length (in)	71.0	N/A	Grade Break?	N/A
Yes	Ramp Width (in)	70.0	N/A	Grade Break Slope (%)	0.0
Yes	Ramp Slope (%)	1.6	N/A	Grade Break XSlope (%)	0.0
No	Ramp XSlope (%)	2.7			
N/A	Flare Type LT	N/A	N/A	Flare Type RT	N/A
N/A	Flare Slope LT (%)	N/A	N/A	Flare Slope RT (%)	0.0
N/A	Flare Traversable LT?	N/A	N/A	Flare Traversable RT?	N/A
N/A	Landing Length (in)	0.0	N/A	DWS Provided?	N/A
N/A	Landing Width (in)	0.0	N/A	DWS Contrast?	N/A
N/A	Landing Slope (%)	0.0	N/A	DWS Length (in)	N/A
N/A	Landing X Slope (%)	0.0	N/A	DWS Full Width?	N/A
N/A	Landing Curb? (Y/N)	N/A	N/A	DWS Offset LT (in)	N/A
N/A	Shared Landing?	N/A	N/A	DWS Offset RT (in)	N/A
N/A	Gutter Ponding?	0.0	N/A	Gutter Slope (%)	N/A
N/A	Gutter Lip Ht (in)	0.0	N/A	Gutter X Slope (%)	N/A
N/A	Painted X Walk1?	No		Road Slope (%)	4.0
	X Walk 1 Direction	To SW		Road X Slope (%)	0.6
	X Walk 1 Width (in)	N/A		Clear Space?	N/A

X Walk 1 Slope (%)	4.0	N/A	Clear Space to XWalk (in)	N/A
	X Walk 1 X Slope (%)	0.6	N/A	Storm Grate/Utility Hazard?	N/A
N/A	Ramp inside XWalk1?	N/A		Storm Grate/Utility Type	
N/A	Any Obstructions?	N/A			N/A
	Obstruction Type		Yes	Surface Condition? (G/P)	Good
			N/A	Curb Slope (%)	10.2

Possible Solutions:

**Remove & Replace Entire Ramp.**

**R304.5.3**
