# Access Compliance Report

## Public Rights-of-Way

### (Curb Ramps)

Intersection ID: 10040796	Main Street: W W T HARRIS BV	Cross Street: N/A	Location: SE
ADA ID: 187FE0C0CEDC	Ramp Type: Directional1	Initial Pass/Fail: Pass	Overall Compliance: No
Codes/Mitigation Info/Possible Solution		Field Measurements/Component Compliance	
Severity Score: 10.25

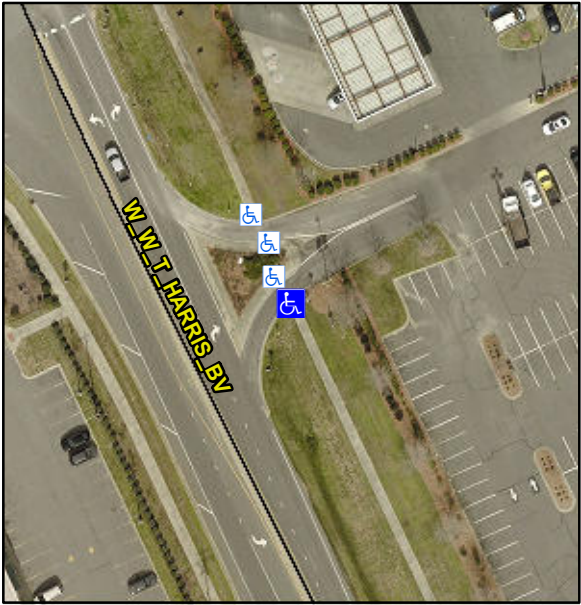
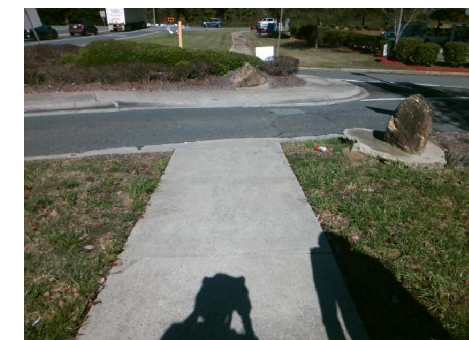
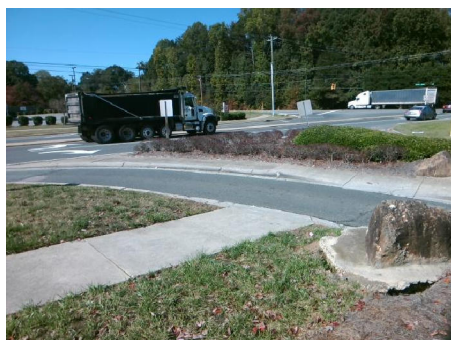
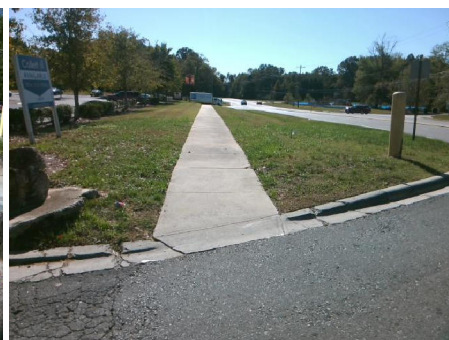
Possible Solutions:						
	Remove & Replace Entire Ramp.	N/A	Ramp Length (in)	40.0	No	Grade Break?	No
	Remove & Replace Gutter.	Yes	Ramp Width (in)	60.0	N/A	Grade Break Slope (%)	N/A
		Yes	Ramp Slope (%)	1.3	N/A	Grade Break XSlope (%)	N/A
		No	Ramp XSlope (%)	2.9			
		N/A	Flare Type LT	N/A	N/A	Flare Type RT	N/A
		N/A	Flare Slope LT (%)	N/A	N/A	Flare Slope RT (%)	N/A
		N/A	Flare Traversable LT?	N/A	N/A	Flare Traversable RT?	N/A
	Surveyor Notes:	Yes	Landing Length (in)	60.0	No	DWS Provided?	No
	N/A	Yes	Landing Width (in)	60.0	N/A	DWS Contrast?	No
<p>PROW/ADA:</p> <p><b>R304.5.3, R304.2.2-Perp, R304.3.2-Para, R304.5.2, R305</b></p>		No	Landing Slope (%)	2.6	N/A	DWS Length (in)	N/A
		Yes	Landing X Slope (%)	0.3	N/A	DWS Full Width?	No
		N/A	Landing Curb? (Y/N)	N/A	N/A	DWS Offset LT (in)	N/A
		N/A	Shared Landing?	No	N/A	DWS Offset RT (in)	N/A
		Yes	Gutter Ponding?	No	Yes	Gutter Slope (%)	1.2
		Yes	Gutter Lip Ht (in)	0.0	No	Gutter X Slope (%)	2.9

N/A	Painted X Walk1?	No		Road Slope (%)	1.1
			X Walk 1 Direction	To N		Road X Slope (%)	2.1
			X Walk 1 Width (in)	N/A		Clear Space?	Yes
			X Walk 1 Slope (%)	1.1	N/A	Clear Space to XWalk (in)	N/A
<p>Total Cost: \$ 2350.00</p>			X Walk 1 X Slope (%)	2.1	Yes	Storm Grate/Utility Hazard?	No
		N/A	Ramp inside XWalk1?	N/A		Storm Grate/Utility Type	
		Yes	Any Obstructions?	No			N/A
			Obstruction Type		Yes	Surface Condition? (G/P)	Good
					N/A	Curb Slope (%)	5.1
