# Access Compliance Report

## Public Rights-of-Way

### (Curb Ramps)

| Intersection ID: 17113 | Main Street: STERLING_RD | Cross Street: WESTFIELD_RD | Location: SE |

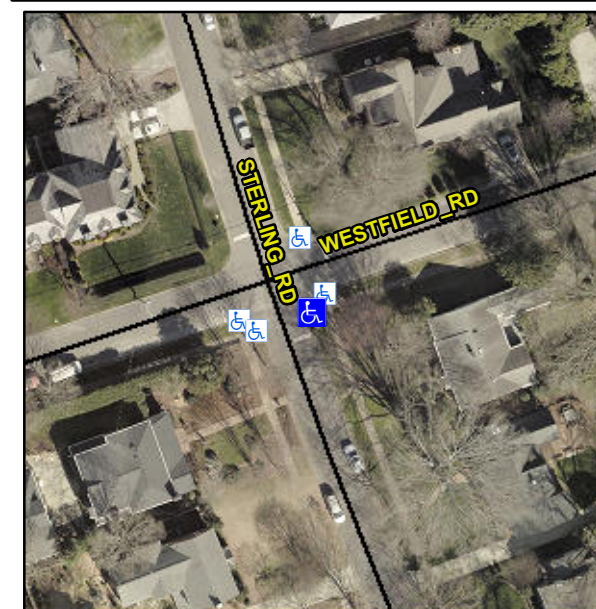
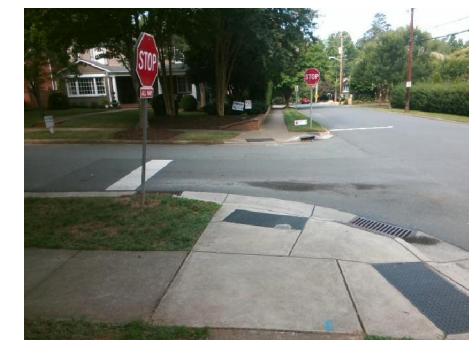
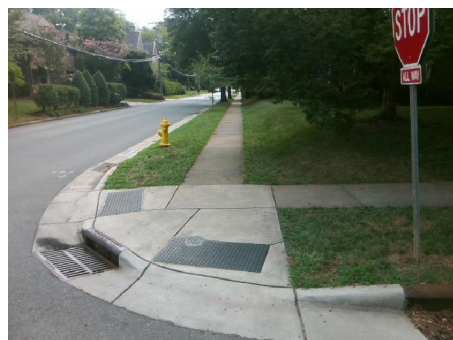
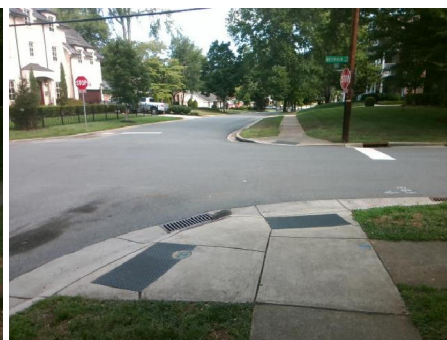
| ADA ID: 188274422714 | Ramp Type: Directional1 | Initial Pass/Fail: Fail | Overall Compliance: No |

**R304.5.1, R304.2.2, R304.5.3**

| Compliance | Description | Data | Compliance | Description | Data |
|---|---|---|---|---|---|
| No | Ramp Width (in) | 45.0 | N/A | Grade Break Slope (%) | 0.0 |
| No | Ramp Slope (%) | 9.9 | N/A | Grade Break XSlope (%) | 0.0 |
| No | Ramp XSlope (%) | 4.2 | | | |

**Remove & Replace Entire Ramp.**
