# Access Compliance Report

## Public Rights-of-Way

### (Curb Ramps)

Intersection ID: 12797	Main Street: N_MYERS_ST	Cross Street: E_6TH_ST	Location: S
ADA ID: 188B2C79DFFC	Ramp Type: PerpDiag	Initial Pass/Fail: Fail	Overall Compliance: No
Severity Score: 46.25			
Codes/Mitigation Info/Possible Solution		Field Measurements/Component Compliance

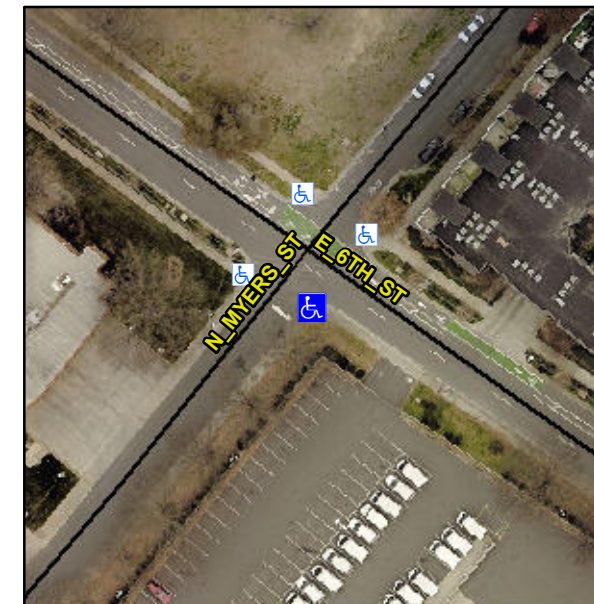
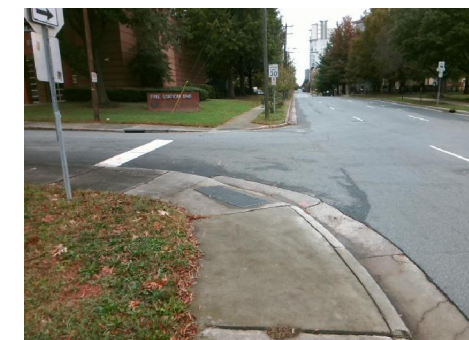
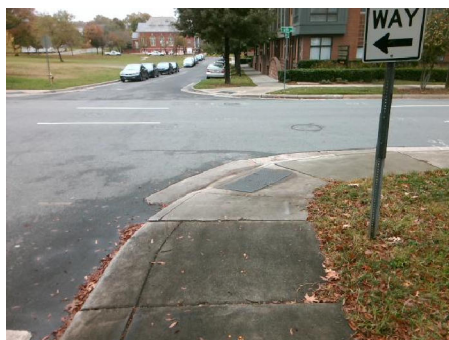
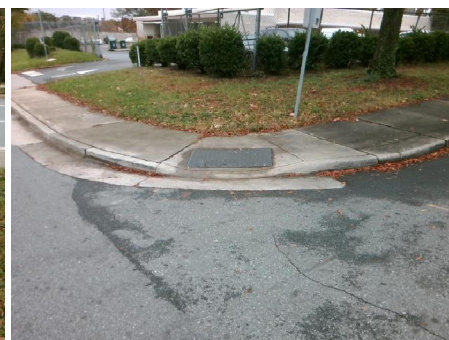
**Not Found, R304.5.1, R304.2.2, R304.5.3**

Compliance	Description	Data	Compliance	Description	Data
N/A	Ramp Length (in)	67.0	No	Ramp Slope (%)	9.7
No	Ramp Width (in)	38.0	No	Ramp XSlope (%)	7.3
N/A	Flare Type LT	N/A	N/A	Flare Type RT	N/A
N/A	Flare Slope LT (%)	N/A	N/A	Flare Slope RT (%)	N/A
N/A	Flare Traversable LT?	N/A	N/A	Flare Traversable RT?	N/A
N/A	Landing Length (in)	N/A	N/A	DWS Provided?	N/A
N/A	Landing Width (in)	N/A	N/A	DWS Contrast?	N/A
N/A	Landing Slope (%)	N/A	N/A	DWS Length (in)	N/A
N/A	Landing X Slope (%)	N/A	N/A	DWS Full Width?	N/A
N/A	Landing Curb? (Y/N)	N/A	N/A	DWS Offset (in)	N/A
N/A	Shared Landing?	N/A			
N/A	Gutter Ponding?	N/A	N/A	Gutter Slope (%)	N/A
N/A	Gutter Lip Ht (in)	N/A	N/A	Gutter X Slope (%)	N/A
N/A	Painted X Walk1?	No	N/A	Painted X Walk2?	No
	X Walk 1 Direction	To NE		X Walk 2 Direction	To NW
N/A	X Walk 1 Width (in)	N/A	N/A	X Walk 2 Width (in)	N/A
	X Walk 1 Slope (%)	0.5		X Walk 2 Slope (%)	7.0
	X Walk 1 X Slope (%)	4.2		X Walk 2 X Slope (%)	1.9

N/A	Ramp inside XWalk1?	N/A	N/A	Ramp inside XWalk2?	N/A
	Road Slope (%)	4.0	N/A	Clear Space?	N/A
	Road X Slope (%)	3.8	N/A	Clear Space to XWalk (in)	N/A
N/A	Any Obstructions?	N/A	N/A	Storm Grate/Utility Hazard?	N/A
	Obstruction Type			Storm Grate/Utility Type	
		N/A			N/A
			Yes	Surface Condition? (G/P)	Good

**Remove & Replace Curb Ramp With Two New Directional Ramps or Equivalent.**
