Access Compliance Report Public Rights-of-Way (Curb Ramps)

Intersection ID: 10041624	Main Street: WHITEHALL EXECUTIVE CENTER DR	Access Street: N/A	Location: W
ADA ID: 1890A86E34C1	Ramp Type: Combination1	Initial Pass/Fail: Fail	Overall Compliance: No
		Severity Score: 1.25

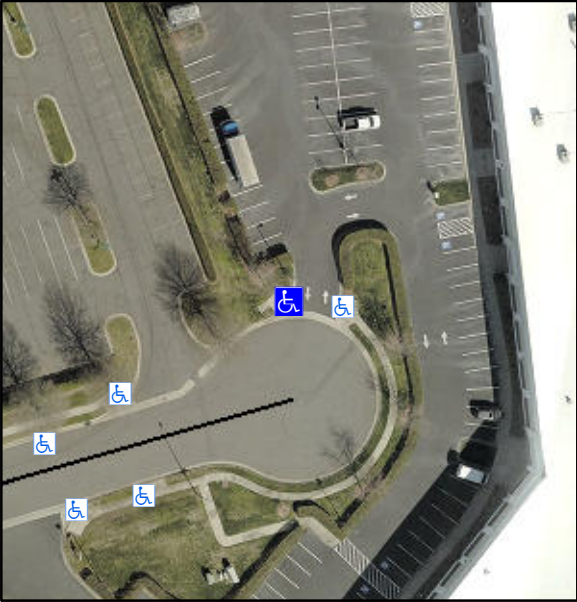
Possible Solutions:		Compliance	Description	Data	
	Remove & Replace Entire Ramp.		N/A	Ramp Length LT (in)	38.0	
			Yes	Ramp Width LT (in)	48.0	
			Yes	Ramp Slope LT (%)	1.2	
			Yes	Ramp XSlope LT (%)	0.9	
			N/A	Ramp Length (in)	48.0	
			Yes	Ramp Width (in)	48.0	
	Surveyor Notes:		N/A	Flare Type LT	N/A	
	LT RP < 5%		N/A	Flare Slope LT (%)	N/A	
			N/A	Flare Traversable LT?	N/A	
	PROW/ADA:		N/A	Landing Length (in)	N/A	
	R304.5.3		N/A	Landing Width (in)	N/A	
			N/A	Landing Slope (%)	N/A	
			N/A	Landing X Slope (%)	N/A	
			N/A	Landing Curb? (Y/N)	N/A	
			N/A	Shared Landing?	N/A	
			N/A	Gutter Ponding?	N/A	
			N/A	Gutter Lip Ht (in)	N/A	
			N/A	Painted X Walk1?	No	
				X Walk 1 Direction	To E	
Street 1 Name	StopSign			X Walk 1 Width (in)	N/A	
Stop Condition-Street 1	ENTRANCE			X Walk 1 Slope (%)	1.8	
Street 2 Name	N/A			X Walk 1 X Slope (%)	3.7

Stop Condition-Street 2	N/A			Ramp inside XWalk1?	N/A	
Total Cost:		\$ 1800.00	N/A	Road Slope (%)	N/A	
				Road X Slope (%)	N/A	
				Clear Space?	N/A	
				Clear Space to XWalk (in)	N/A	
				Any Obstruction?	N/A	
				Obstruction Type		
						N/A
			N/A	Storm Grate/Utility Hazard?	N/A	
				Storm Grate/Utility Type		
						N/A
			Yes	Surface Condition? (G/P)	Good	
				Curb Slope (%)	2.4
