Access Compliance Report

Public Rights-of-Way

(Curb Ramps)

Intersection ID: 5506	Main Street: COLIN_CREEK_LN	Cross Street: MOUNTAIN_FLOWER_CT	Location: S
ADA ID: 1896F880A088	Ramp Type: Perp	Initial Pass/Fail: Fail	Overall Compliance: No
Severity Score: 1.25			
Codes/Mitigation Info/Possible Solution		Field Measurements/Component Compliance

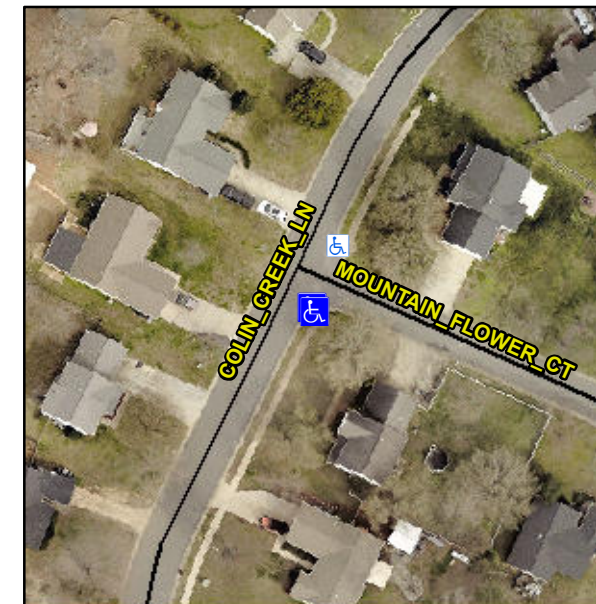
Not Found, R304.5.3

Compliance	Description	Data	Compliance	Description	Data
N/A	Ramp Length (in)	48.0	Yes	Ramp Slope (%)	5.5
Yes	Ramp Width (in)	48.0	No	Ramp XSlope (%)	4.7
N/A	Flare Type LT	N/A	N/A	Flare Type RT	N/A
N/A	Flare Slope LT (%)	N/A	N/A	Flare Slope RT (%)	N/A
N/A	Flare Traversable LT?	N/A	N/A	Flare Traversable RT?	N/A
N/A	Landing Length (in)	N/A	N/A	DWS Provided?	N/A
N/A	Landing Width (in)	N/A	N/A	DWS Contrast?	N/A
N/A	Landing Slope (%)	N/A	N/A	DWS Length (in)	N/A
N/A	Landing X Slope (%)	N/A	N/A	DWS Full Width?	N/A
N/A	Landing Curb? (Y/N)	N/A	N/A	DWS Offset (in)	N/A
N/A	Shared Landing?	N/A			
N/A	Gutter Ponding?	N/A	N/A	Gutter Slope (%)	N/A
N/A	Gutter Lip Ht (in)	N/A	N/A	Gutter X Slope (%)	N/A
N/A	Painted X Walk1?	No	N/A	Painted X Walk2?	N/A
	X Walk 1 Direction	To N		X Walk 2 Direction	N/A
N/A	X Walk 1 Width (in)	N/A	N/A	X Walk 2 Width (in)	N/A
	X Walk 1 Slope (%)	0.6		X Walk 2 Slope (%)	N/A
	X Walk 1 X Slope (%)	2.2		X Walk 2 X Slope (%)	N/A

N/A	Ramp inside XWalk1?	N/A	N/A	Ramp inside XWalk2?	N/A
	Road Slope (%)	N/A	N/A	Clear Space?	N/A
	Road X Slope (%)	N/A	N/A	Clear Space to XWalk (in)	N/A
N/A	Any Obstructions?	N/A	N/A	Storm Grate/Utility Hazard?	N/A
	Obstruction Type			Storm Grate/Utility Type	
		N/A			N/A
			Yes	Surface Condition? (G/P)	Good

Remove & Replace Entire Ramp.
