Access Compliance Report

Public Rights-of-Way

(Curb Ramps)

Intersection ID: 49395	Main Street: ROMANA_RED_LN	Cross Street: DAMASCUS_ST	Location: NE
ADA ID: 18A0B67B0FE5	Ramp Type: PerpDiag	Initial Pass/Fail: Fail	Overall Compliance: No
Severity Score: 8.75			
Codes/Mitigation Info/Possible Solution		Field Measurements/Component Compliance

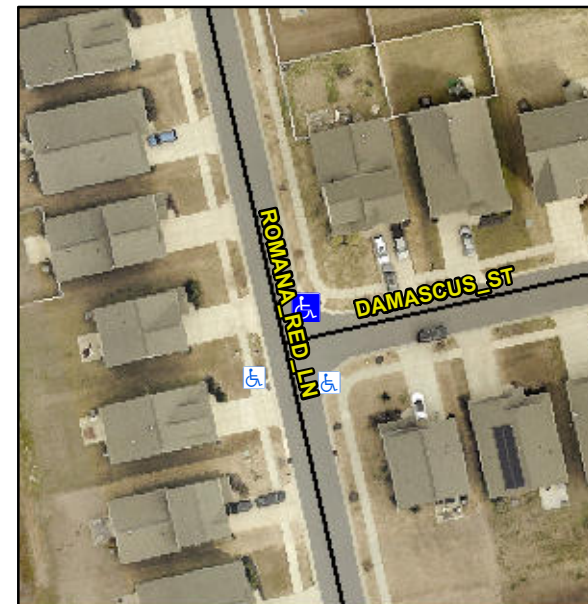
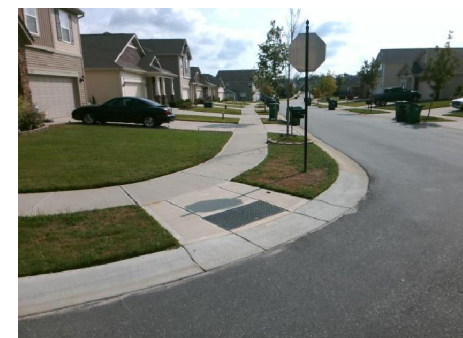
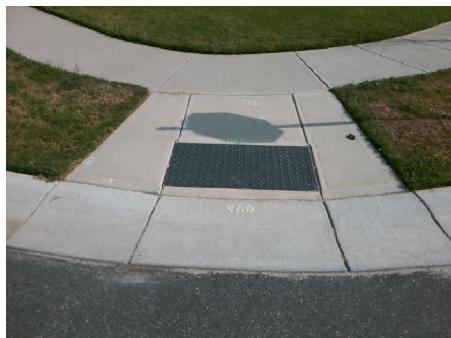
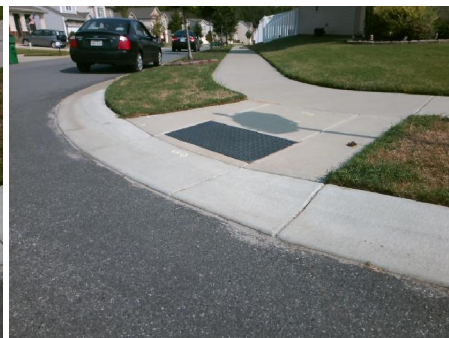
Not Found, R304.5.1

Compliance	Description	Data	Compliance	Description	Data
N/A	Ramp Length (in)	69.0	Yes	Ramp Slope (%)	5.3
No	Ramp Width (in)	46.0	Yes	Ramp XSlope (%)	0.2
N/A	Flare Type LT	N/A	N/A	Flare Type RT	N/A
N/A	Flare Slope LT (%)	N/A	N/A	Flare Slope RT (%)	N/A
N/A	Flare Traversable LT?	N/A	N/A	Flare Traversable RT?	N/A
N/A	Landing Length (in)	N/A	N/A	DWS Provided?	N/A
N/A	Landing Width (in)	N/A	N/A	DWS Contrast?	N/A
N/A	Landing Slope (%)	N/A	N/A	DWS Length (in)	N/A
N/A	Landing X Slope (%)	N/A	N/A	DWS Full Width?	N/A
N/A	Landing Curb? (Y/N)	N/A	N/A	DWS Offset (in)	N/A
N/A	Shared Landing?	N/A			
N/A	Gutter Ponding?	N/A	N/A	Gutter Slope (%)	N/A
N/A	Gutter Lip Ht (in)	N/A	N/A	Gutter X Slope (%)	N/A
N/A	Painted X Walk1?	No	N/A	Painted X Walk2?	No
	X Walk 1 Direction	To W		X Walk 2 Direction	To S
N/A	X Walk 1 Width (in)	N/A	N/A	X Walk 2 Width (in)	N/A
	X Walk 1 Slope (%)	2.4		X Walk 2 Slope (%)	2.3
	X Walk 1 X Slope (%)	1.9		X Walk 2 X Slope (%)	1.6

N/A	Ramp inside XWalk1?	N/A	N/A	Ramp inside XWalk2?	N/A
	Road Slope (%)	2.5	N/A	Clear Space?	N/A
	Road X Slope (%)	4.9	N/A	Clear Space to XWalk (in)	N/A
N/A	Any Obstructions?	N/A	N/A	Storm Grate/Utility Hazard?	N/A
	Obstruction Type			Storm Grate/Utility Type	
		N/A			N/A
			Yes	Surface Condition? (G/P)	Good

Remove & Replace Curb Ramp With Two New Directional Ramps or Equivalent.

Total Cost: \$ 3200.00
