Access Compliance Report

Public Rights-of-Way (Curb Ramps)

Intersection ID: N/A	Main Street: HONEYMEADE_CR	Cross Street: PROVIDENCE_COUNTRY_CLUB_DR	Location: SW
ADA ID: 18AD4278442D	Ramp Type: Perp	Initial Pass/Fail: Fail	Overall Compliance: No
Severity Score: 1.25			
Codes/Mitigation Info/Possible Solution		Field Measurements/Component Compliance

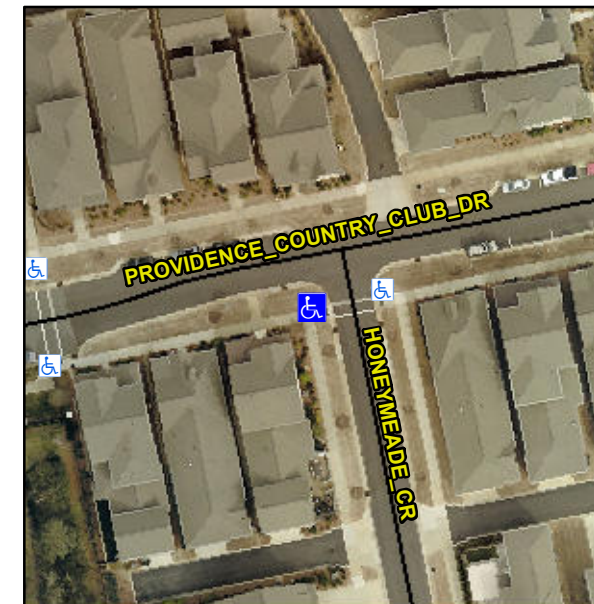
Not Found, R304.5.3

Compliance	Description	Data	Compliance	Description	Data
N/A	Ramp Length (in)	96.0	Yes	Ramp Slope (%)	5.4
Yes	Ramp Width (in)	71.0	No	Ramp XSlope (%)	2.7
N/A	Flare Type LT	N/A	N/A	Flare Type RT	N/A
N/A	Flare Slope LT (%)	N/A	N/A	Flare Slope RT (%)	N/A
N/A	Flare Traversable LT?	N/A	N/A	Flare Traversable RT?	N/A
N/A	Landing Length (in)	N/A	N/A	DWS Provided?	N/A
N/A	Landing Width (in)	N/A	N/A	DWS Contrast?	N/A
N/A	Landing Slope (%)	N/A	N/A	DWS Length (in)	N/A
N/A	Landing X Slope (%)	N/A	N/A	DWS Full Width?	N/A
N/A	Landing Curb? (Y/N)	N/A	N/A	DWS Offset (in)	N/A
N/A	Shared Landing?	N/A			
N/A	Gutter Ponding?	N/A	N/A	Gutter Slope (%)	N/A
N/A	Gutter Lip Ht (in)	N/A	N/A	Gutter X Slope (%)	N/A
N/A	Painted X Walk1?	No	N/A	Painted X Walk2?	N/A
	X Walk 1 Direction	To E		X Walk 2 Direction	N/A
N/A	X Walk 1 Width (in)	N/A	N/A	X Walk 2 Width (in)	N/A
	X Walk 1 Slope (%)	1.1		X Walk 2 Slope (%)	N/A
	X Walk 1 X Slope (%)	0.8		X Walk 2 X Slope (%)	N/A

N/A	Ramp inside XWalk1?	N/A	N/A	Ramp inside XWalk2?	N/A
	Road Slope (%)	N/A	N/A	Clear Space?	N/A
	Road X Slope (%)	N/A	N/A	Clear Space to XWalk (in)	N/A
N/A	Any Obstructions?	N/A	N/A	Storm Grate/Utility Hazard?	N/A
	Obstruction Type			Storm Grate/Utility Type	
		N/A			N/A
		Yes		Surface Condition? (G/P)	Good

Remove & Replace Entire Ramp.
