# Access Compliance Report

## Public Rights-of-Way

### (Curb Ramps)

Intersection ID: N/A	Main Street: 24TH_ST	Cross Street: N/A	Location: N
ADA ID: 18BEDA26819F	Ramp Type: ParaDiag	Initial Pass/Fail: Fail	Overall Compliance: No
			Severity Score: 28.75

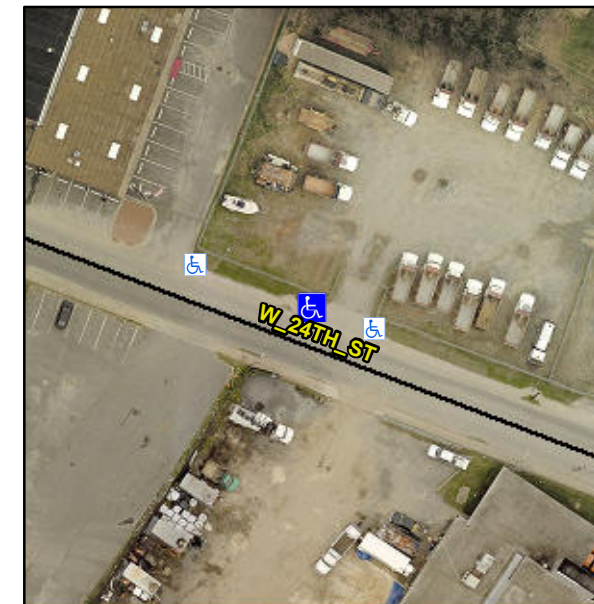
**PONDING PREVENTED ROAD SLOPES**

Compliance	Description	Data	Compliance	Description	Data
N/A	Ramp Length LT (in)	56.0	N/A	Ramp Length RT (in)	55.0
Yes	Ramp Width LT (in)	60.0	Yes	Ramp Width RT (in)	60.0
Yes	Ramp Slope LT (%)	3.3	No	Ramp Slope RT (%)	9.0
No	Ramp XSlope LT (%)	3.6	No	Ramp XSlope RT (%)	3.7
N/A	Landing Length (in)	N/A	N/A	DWS Provided?	N/A
N/A	Landing Width (in)	N/A	N/A	DWS Contrast?	N/A
N/A	Landing Slope (%)	N/A	N/A	DWS Length (in)	N/A
N/A	Landing X Slope (%)	N/A	N/A	DWS Full Width?	N/A
N/A	Landing Curb? (Y/N)	N/A	N/A	DWS Offset (in)	N/A
N/A	Shared Landing?	N/A			
N/A	Gutter Ponding?	N/A	N/A	Gutter Slope (%)	N/A
N/A	Gutter Lip Ht (in)	N/A	N/A	Gutter X Slope (%)	N/A
N/A	Painted X Walk1?	No	N/A	Painted X Walk2?	No
	X Walk 1 Direction	To SE		X Walk 2 Direction	To S
N/A	X Walk 1 Width (in)	N/A	N/A	X Walk 2 Width (in)	N/A
	X Walk 1 Slope (%)	2.4		X Walk 2 Slope (%)	0.7
	X Walk 1 X Slope (%)	0.3		X Walk 2 X Slope (%)	2.7
N/A	Ramp inside XWalk1?	N/A	N/A	Ramp inside XWalk2?	N/A

Road Slope (%)	N/A	N/A	Clear Space?	N/A
	Road X Slope (%)	N/A	N/A	Clear Space to XWalk (in)	N/A
N/A	Any Obstructions?	N/A	N/A	Storm Grate/Utility Hazard?	N/A
	Obstruction Type			Storm Grate/Utility Type	
		N/A			N/A
			No	Surface Condition? (G/P)	Poor
			N/A	Curb Slope (%)	9.8

**Remove & Replace Curb Ramp With Two New Directional Ramps or Equivalent.**
