# Access Compliance Report

## Public Rights-of-Way

### (Curb Ramps)

Intersection ID: 14846	Main Street: HENLEY_PL	Cross Street: S_KINGS_DR	Location: E
ADA ID: 18C16DB15246	Ramp Type: Perp	Initial Pass/Fail: Fail	Overall Compliance: No
Codes/Mitigation Info/Possible Solution		Field Measurements/Component Compliance	
Severity Score: 26.25

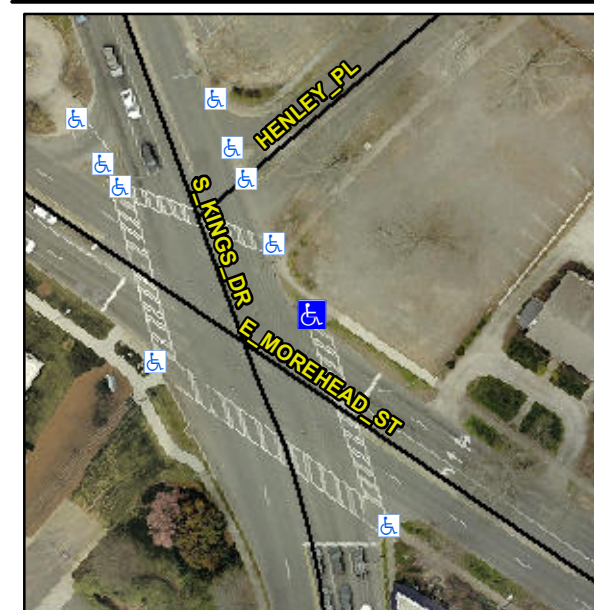
**Not Found, R304.2.2**

Compliance	Description	Data	Compliance	Description	Data
N/A	Ramp Length (in)	69.0	No	Ramp Slope (%)	12.8
Yes	Ramp Width (in)	48.0	Yes	Ramp XSlope (%)	2.4
N/A	Flare Type LT	N/A	N/A	Flare Type RT	N/A
N/A	Flare Slope LT (%)	N/A	N/A	Flare Slope RT (%)	N/A
N/A	Flare Traversable LT?	N/A	N/A	Flare Traversable RT?	N/A
N/A	Landing Length (in)	N/A	N/A	DWS Provided?	N/A
N/A	Landing Width (in)	N/A	N/A	DWS Contrast?	N/A
N/A	Landing Slope (%)	N/A	N/A	DWS Length (in)	N/A
N/A	Landing X Slope (%)	N/A	N/A	DWS Full Width?	N/A
N/A	Landing Curb? (Y/N)	N/A	N/A	DWS Offset (in)	N/A
N/A	Shared Landing?	N/A			
N/A	Gutter Ponding?	N/A	N/A	Gutter Slope (%)	N/A
N/A	Gutter Lip Ht (in)	N/A	N/A	Gutter X Slope (%)	N/A
N/A	Painted X Walk1?	Yes	N/A	Painted X Walk2?	N/A
	X Walk 1 Direction	To S		X Walk 2 Direction	N/A
N/A	X Walk 1 Width (in)	177.0	N/A	X Walk 2 Width (in)	N/A
	X Walk 1 Slope (%)	4.5		X Walk 2 Slope (%)	N/A
	X Walk 1 X Slope (%)	3.0		X Walk 2 X Slope (%)	N/A

N/A	Ramp inside XWalk1?	Yes	N/A	Ramp inside XWalk2?	N/A
	Road Slope (%)	N/A	N/A	Clear Space?	N/A
	Road X Slope (%)	N/A	N/A	Clear Space to XWalk (in)	N/A
N/A	Any Obstructions?	N/A	N/A	Storm Grate/Utility Hazard?	N/A
	Obstruction Type			Storm Grate/Utility Type	
		N/A			N/A
			Yes	Surface Condition? (G/P)	Good

**Remove & Replace Entire Ramp.**

Total Cost: \$ 1850.00
