# Access Compliance Report

## Public Rights-of-Way (Curb Ramps)

Intersection ID: 53416	Main Street: WAVERLY_CENTER_DR	Cross Street: SOUTHGROVE_ST	Location: NE
ADA ID: 18CB5A96CA04	Ramp Type: Perp	Initial Pass/Fail: Fail	Overall Compliance: No
Severity Score: 25			
Codes/Mitigation Info/Possible Solution		Field Measurements/Component Compliance

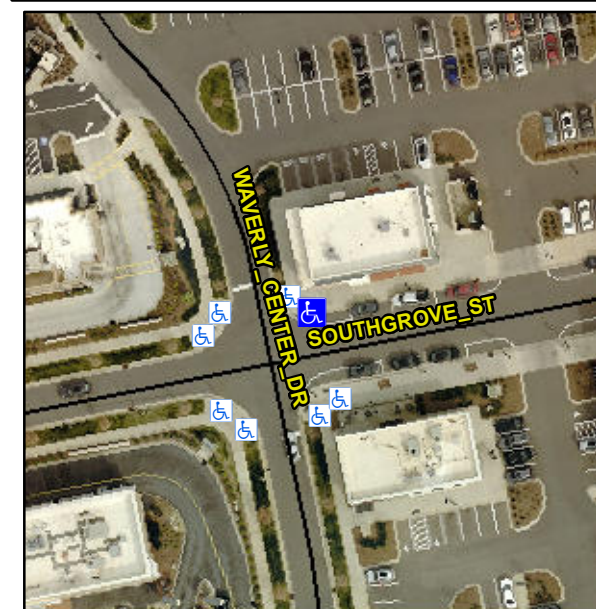
**R304.2.2**

Compliance	Description	Data	Compliance	Description	Data
N/A	Ramp Length (in)	61.0	No	Ramp Slope (%)	12.8
Yes	Ramp Width (in)	48.0	Yes	Ramp XSlope (%)	0.2
N/A	Flare Type LT	N/A	N/A	Flare Type RT	N/A
N/A	Flare Slope LT (%)	N/A	N/A	Flare Slope RT (%)	N/A
N/A	Flare Traversable LT?	N/A	N/A	Flare Traversable RT?	N/A
N/A	Landing Length (in)	N/A	N/A	DWS Provided?	N/A
N/A	Landing Width (in)	N/A	N/A	DWS Contrast?	N/A
N/A	Landing Slope (%)	N/A	N/A	DWS Length (in)	N/A
N/A	Landing X Slope (%)	N/A	N/A	DWS Full Width?	N/A
N/A	Landing Curb? (Y/N)	N/A	N/A	DWS Offset (in)	N/A
N/A	Shared Landing?	N/A			
N/A	Gutter Ponding?	N/A	N/A	Gutter Slope (%)	N/A
N/A	Gutter Lip Ht (in)	N/A	N/A	Gutter X Slope (%)	N/A
N/A	Painted X Walk1?	No	N/A	Painted X Walk2?	N/A
	X Walk 1 Direction	To S		X Walk 2 Direction	N/A
N/A	X Walk 1 Width (in)	N/A	N/A	X Walk 2 Width (in)	N/A
	X Walk 1 Slope (%)	1.8		X Walk 2 Slope (%)	N/A
	X Walk 1 X Slope (%)	0.5		X Walk 2 X Slope (%)	N/A

**Remove & Replace Entire Ramp.**
