Access Compliance Report

Public Rights-of-Way

(Curb Ramps)

Intersection ID: 30613	Main Street: GOLF_LINKS_DR	Cross Street: PROVIDENCE_RD	Location: NE
ADA ID: 18CBCC478813	Ramp Type: Perp	Initial Pass/Fail: Fail	Overall Compliance: No
		Severity Score: 12.5

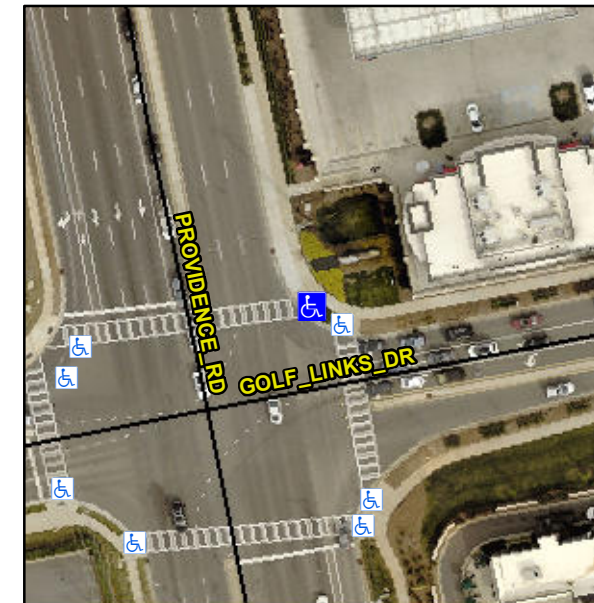
Not Found, R304.5.3

Compliance	Description	Data	Compliance	Description	Data
N/A	Ramp Length (in)	96.0	Yes	Ramp Slope (%)	7.8
Yes	Ramp Width (in)	48.0	No	Ramp XSlope (%)	6.6
N/A	Flare Type LT	N/A	N/A	Flare Type RT	N/A
N/A	Flare Slope LT (%)	N/A	N/A	Flare Slope RT (%)	N/A
N/A	Flare Traversable LT?	N/A	N/A	Flare Traversable RT?	N/A
N/A	Landing Length (in)	N/A	N/A	DWS Provided?	N/A
N/A	Landing Width (in)	N/A	N/A	DWS Contrast?	N/A
N/A	Landing Slope (%)	N/A	N/A	DWS Length (in)	N/A
N/A	Landing X Slope (%)	N/A	N/A	DWS Full Width?	N/A
N/A	Landing Curb? (Y/N)	N/A	N/A	DWS Offset (in)	N/A
N/A	Shared Landing?	N/A			
N/A	Gutter Ponding?	N/A	N/A	Gutter Slope (%)	N/A
N/A	Gutter Lip Ht (in)	N/A	N/A	Gutter X Slope (%)	N/A
N/A	Painted X Walk1?	Yes	N/A	Painted X Walk2?	N/A
	X Walk 1 Direction	To W		X Walk 2 Direction	N/A
N/A	X Walk 1 Width (in)	105.0	N/A	X Walk 2 Width (in)	N/A
	X Walk 1 Slope (%)	2.5		X Walk 2 Slope (%)	N/A
	X Walk 1 X Slope (%)	6.0		X Walk 2 X Slope (%)	N/A

N/A	Ramp inside XWalk1?	Yes	N/A	Ramp inside XWalk2?	N/A
	Road Slope (%)	N/A	N/A	Clear Space?	N/A
	Road X Slope (%)	N/A	N/A	Clear Space to XWalk (in)	N/A
N/A	Any Obstructions?	N/A	N/A	Storm Grate/Utility Hazard?	N/A
	Obstruction Type			Storm Grate/Utility Type	
		N/A			N/A
			Yes	Surface Condition? (G/P)	Good

Possible Solutions:

Remove & Replace Entire Ramp.
