# Access Compliance Report

## Public Rights-of-Way

### (Curb Ramps)

Intersection ID: 30037	Main Street: MORNING_CREEK_LN	Cross Street: TWIN_ASH_CT	Location: S
ADA ID: 18CE9E05DB77	Ramp Type: PerpDiag	Initial Pass/Fail: Fail	Overall Compliance: No
		Severity Score: 8.75

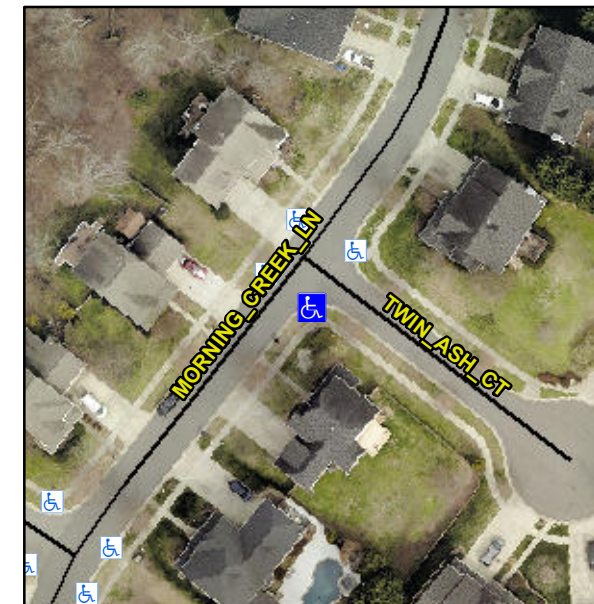
**Not Found, R304.5.1**

Compliance	Description	Data	Compliance	Description	Data
N/A	Ramp Length (in)	70.0	Yes	Ramp Slope (%)	5.0
No	Ramp Width (in)	45.0	Yes	Ramp XSlope (%)	1.0
N/A	Flare Type LT	N/A	N/A	Flare Type RT	N/A
N/A	Flare Slope LT (%)	N/A	N/A	Flare Slope RT (%)	N/A
N/A	Flare Traversable LT?	N/A	N/A	Flare Traversable RT?	N/A
N/A	Landing Length (in)	N/A	N/A	DWS Provided?	N/A
N/A	Landing Width (in)	N/A	N/A	DWS Contrast?	N/A
N/A	Landing Slope (%)	N/A	N/A	DWS Length (in)	N/A
N/A	Landing X Slope (%)	N/A	N/A	DWS Full Width?	N/A
N/A	Landing Curb? (Y/N)	N/A	N/A	DWS Offset (in)	N/A
N/A	Shared Landing?	N/A			
N/A	Gutter Ponding?	N/A	N/A	Gutter Slope (%)	N/A
N/A	Gutter Lip Ht (in)	N/A	N/A	Gutter X Slope (%)	N/A
N/A	Painted X Walk1?	No	N/A	Painted X Walk2?	No
	X Walk 1 Direction	To NE		X Walk 2 Direction	To NW
N/A	X Walk 1 Width (in)	N/A	N/A	X Walk 2 Width (in)	N/A
	X Walk 1 Slope (%)	2.0		X Walk 2 Slope (%)	4.0
	X Walk 1 X Slope (%)	2.6		X Walk 2 X Slope (%)	2.7

N/A	Ramp inside XWalk1?	N/A	N/A	Ramp inside XWalk2?	N/A
	Road Slope (%)	1.4	N/A	Clear Space?	N/A
	Road X Slope (%)	4.0	N/A	Clear Space to XWalk (in)	N/A
N/A	Any Obstructions?	N/A	N/A	Storm Grate/Utility Hazard?	N/A
	Obstruction Type			Storm Grate/Utility Type	
		N/A			N/A
			Yes	Surface Condition? (G/P)	Good

**Remove & Replace Curb Ramp With Two New Directional Ramps or Equivalent.**
