Access Compliance Report

Public Rights-of-Way

(Curb Ramps)

Intersection ID: 22103	Main Street: BRANDENBURG_CT	Cross Street: HIGHVIEW_RD	Location: W
ADA ID: 18D2E61C2A9D	Ramp Type: PerpDiag	Initial Pass/Fail: Fail	Overall Compliance: No
Severity Score: 46.25			
Codes/Mitigation Info/Possible Solution		Field Measurements/Component Compliance

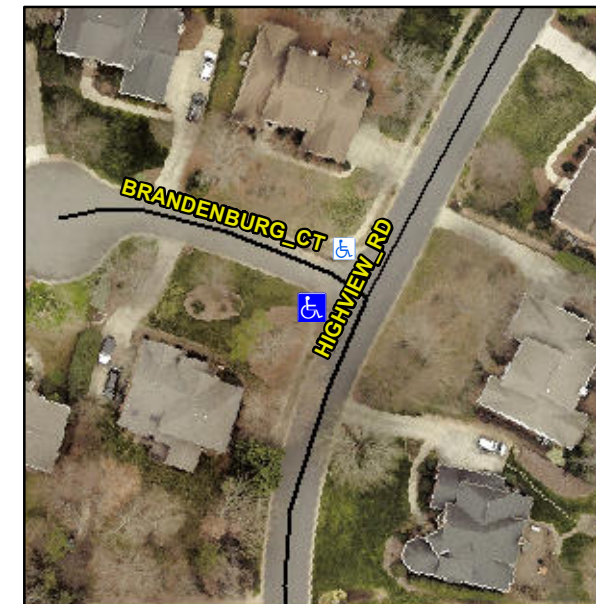
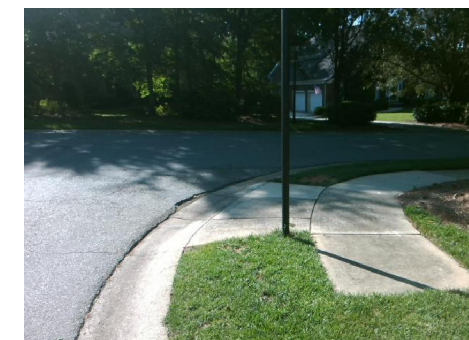
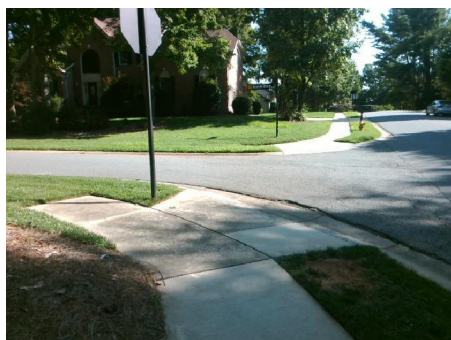
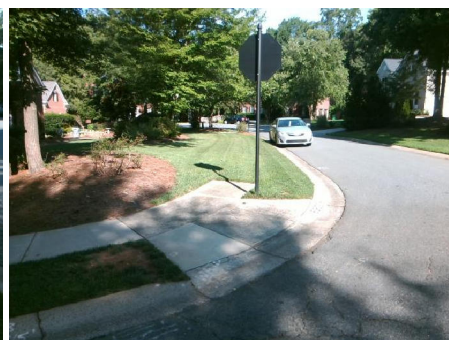
R304.5.1, R304.2.2, R304.5.3

Compliance	Description	Data	Compliance	Description	Data
N/A	Ramp Length (in)	52.0	No	Ramp Slope (%)	8.4
No	Ramp Width (in)	39.0	No	Ramp XSlope (%)	7.8
N/A	Flare Type LT	N/A	N/A	Flare Type RT	N/A
N/A	Flare Slope LT (%)	N/A	N/A	Flare Slope RT (%)	N/A
N/A	Flare Traversable LT?	N/A	N/A	Flare Traversable RT?	N/A
N/A	Landing Length (in)	N/A	N/A	DWS Provided?	N/A
N/A	Landing Width (in)	N/A	N/A	DWS Contrast?	N/A
N/A	Landing Slope (%)	N/A	N/A	DWS Length (in)	N/A
N/A	Landing X Slope (%)	N/A	N/A	DWS Full Width?	N/A
N/A	Landing Curb? (Y/N)	N/A	N/A	DWS Offset (in)	N/A
N/A	Shared Landing?	N/A			
N/A	Gutter Ponding?	N/A	N/A	Gutter Slope (%)	N/A
N/A	Gutter Lip Ht (in)	N/A	N/A	Gutter X Slope (%)	N/A
N/A	Painted X Walk1?	No	N/A	Painted X Walk2?	No
	X Walk 1 Direction	To SE		X Walk 2 Direction	To NE
N/A	X Walk 1 Width (in)	N/A	N/A	X Walk 2 Width (in)	N/A
	X Walk 1 Slope (%)	0.1		X Walk 2 Slope (%)	5.9
	X Walk 1 X Slope (%)	8.1		X Walk 2 X Slope (%)	1.8

N/A	Ramp inside XWalk1?	N/A	N/A	Ramp inside XWalk2?	N/A
	Road Slope (%)	5.5	N/A	Clear Space?	N/A
	Road X Slope (%)	4.7	N/A	Clear Space to XWalk (in)	N/A
N/A	Any Obstructions?	N/A	N/A	Storm Grate/Utility Hazard?	N/A
	Obstruction Type			Storm Grate/Utility Type	
		N/A			N/A
			Yes	Surface Condition? (G/P)	Good

Remove & Replace Curb Ramp With Two New Directional Ramps or Equivalent.
