Access Compliance Report

Public Rights-of-Way

(Curb Ramps)

Intersection ID: 48947	Main Street: DAVID_JENNINGS_AV	Cross Street: PEPPERPIKE_WY	Location: E
ADA ID: 18DB0B96A98A	Ramp Type: Perp	Initial Pass/Fail: Fail	Overall Compliance: No
		Severity Score: 8.75

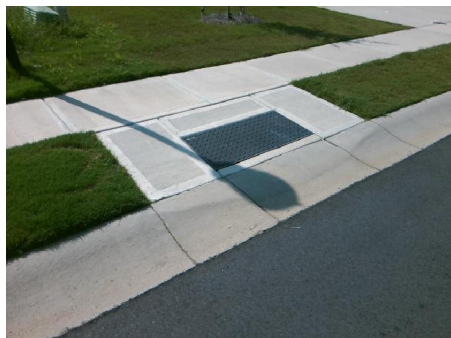
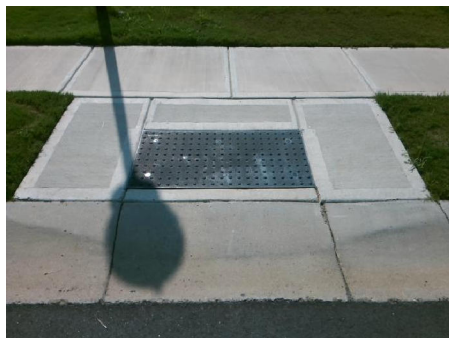
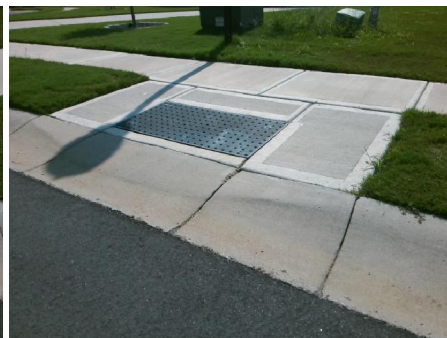
Not Found, R304.5.1

Compliance	Description	Data	Compliance	Description	Data
N/A	Ramp Length (in)	46.0	Yes	Ramp Slope (%)	7.3
No	Ramp Width (in)	47.5	Yes	Ramp XSlope (%)	0.2
N/A	Flare Type LT	N/A	N/A	Flare Type RT	N/A
N/A	Flare Slope LT (%)	N/A	N/A	Flare Slope RT (%)	N/A
N/A	Flare Traversable LT?	N/A	N/A	Flare Traversable RT?	N/A
N/A	Landing Length (in)	N/A	N/A	DWS Provided?	N/A
N/A	Landing Width (in)	N/A	N/A	DWS Contrast?	N/A
N/A	Landing Slope (%)	N/A	N/A	DWS Length (in)	N/A
N/A	Landing X Slope (%)	N/A	N/A	DWS Full Width?	N/A
N/A	Landing Curb? (Y/N)	N/A	N/A	DWS Offset (in)	N/A
N/A	Shared Landing?	N/A			
N/A	Gutter Ponding?	N/A	N/A	Gutter Slope (%)	N/A
N/A	Gutter Lip Ht (in)	N/A	N/A	Gutter X Slope (%)	N/A
N/A	Painted X Walk1?	No	N/A	Painted X Walk2?	N/A
	X Walk 1 Direction	To NW		X Walk 2 Direction	N/A
N/A	X Walk 1 Width (in)	N/A	N/A	X Walk 2 Width (in)	N/A
	X Walk 1 Slope (%)	1.7		X Walk 2 Slope (%)	N/A
	X Walk 1 X Slope (%)	1.5		X Walk 2 X Slope (%)	N/A

N/A	Ramp inside XWalk1?	N/A	N/A	Ramp inside XWalk2?	N/A
	Road Slope (%)	N/A	N/A	Clear Space?	N/A
	Road X Slope (%)	N/A	N/A	Clear Space to XWalk (in)	N/A
N/A	Any Obstructions?	N/A	N/A	Storm Grate/Utility Hazard?	N/A
	Obstruction Type			Storm Grate/Utility Type	
		N/A			N/A
			Yes	Surface Condition? (G/P)	Good

Remove & Replace Entire Ramp.
