Access Compliance Report

Public Rights-of-Way

(Curb Ramps)

Intersection ID: 10028585	Main Street: HOMESTEAD_GLEN_BV	Cross Street: N/A	Location: W
ADA ID: 18E11D5B611E	Ramp Type: Perp	Initial Pass/Fail: Fail	Overall Compliance: No
Severity Score: 21.25			
Codes/Mitigation Info/Possible Solution		Field Measurements/Component Compliance

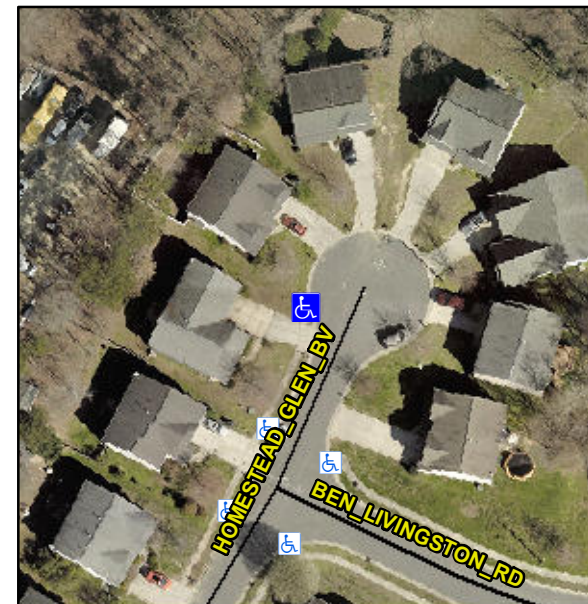
Compliance	Description	Data	Compliance	Description	Data
N/A	Ramp Length (in)	45.5	No	Ramp Slope (%)	8.6
No	Ramp Width (in)	38.0	Yes	Ramp XSlope (%)	1.6
N/A	Flare Type LT	N/A	N/A	Flare Type RT	N/A
N/A	Flare Slope LT (%)	N/A	N/A	Flare Slope RT (%)	N/A
N/A	Flare Traversable LT?	N/A	N/A	Flare Traversable RT?	N/A
N/A	Landing Length (in)	N/A	N/A	DWS Provided?	N/A
N/A	Landing Width (in)	N/A	N/A	DWS Contrast?	N/A
N/A	Landing Slope (%)	N/A	N/A	DWS Length (in)	N/A
N/A	Landing X Slope (%)	N/A	N/A	DWS Full Width?	N/A
N/A	Landing Curb? (Y/N)	N/A	N/A	DWS Offset (in)	N/A
N/A	Shared Landing?	N/A			
N/A	Gutter Ponding?	N/A	N/A	Gutter Slope (%)	N/A
N/A	Gutter Lip Ht (in)	N/A	N/A	Gutter X Slope (%)	N/A
N/A	Painted X Walk1?	No	N/A	Painted X Walk2?	N/A
	X Walk 1 Direction	To E		X Walk 2 Direction	N/A
N/A	X Walk 1 Width (in)	N/A	N/A	X Walk 2 Width (in)	N/A
	X Walk 1 Slope (%)	3.3		X Walk 2 Slope (%)	N/A
	X Walk 1 X Slope (%)	1.3		X Walk 2 X Slope (%)	N/A

N/A	Ramp inside XWalk1?	N/A	N/A	Ramp inside XWalk2?	N/A
	Road Slope (%)	1.3	N/A	Clear Space?	N/A
	Road X Slope (%)	3.3	N/A	Clear Space to XWalk (in)	N/A
N/A	Any Obstructions?	N/A	N/A	Storm Grate/Utility Hazard?	N/A
	Obstruction Type			Storm Grate/Utility Type	
		N/A			N/A
			Yes	Surface Condition? (G/P)	Good

Possible Solutions:

Remove & Replace Entire Ramp.
