# Access Compliance Report

## Public Rights-of-Way

### (Curb Ramps)

Intersection ID: 29721	Main Street: COLE_MILL_RD	Cross Street: LANNIER_FALLS_LN	Location:	N
ADA ID: 18EA1A2BAD36	Ramp Type: Perp	Initial Pass/Fail: Fail	Overall Compliance: No	Severity Score: 10
Codes/Mitigation Info/Possible Solution		Field Measurements/Component Compliance

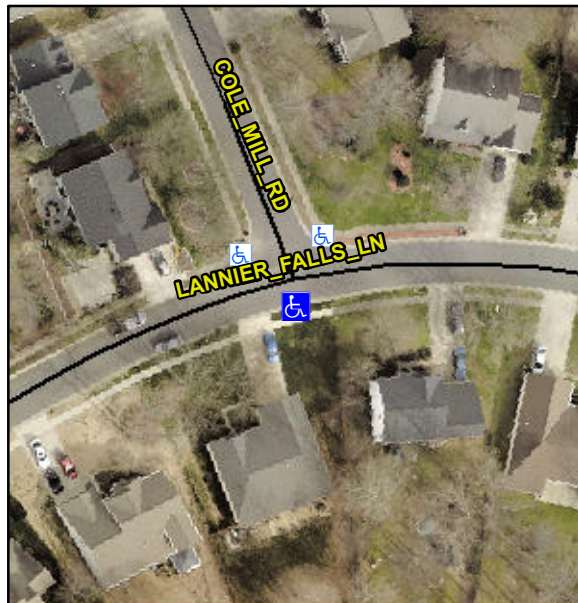
**Not Found, R304.5.1, R304.5.3**

Compliance	Description	Data	Compliance	Description	Data
N/A	Ramp Length (in)	47.5	Yes	Ramp Slope (%)	5.3
No	Ramp Width (in)	47.0	No	Ramp XSlope (%)	4.1
N/A	Flare Type LT	N/A	N/A	Flare Type RT	N/A
N/A	Flare Slope LT (%)	N/A	N/A	Flare Slope RT (%)	N/A
N/A	Flare Traversable LT?	N/A	N/A	Flare Traversable RT?	N/A
N/A	Landing Length (in)	N/A	N/A	DWS Provided?	N/A
N/A	Landing Width (in)	N/A	N/A	DWS Contrast?	N/A
N/A	Landing Slope (%)	N/A	N/A	DWS Length (in)	N/A
N/A	Landing X Slope (%)	N/A	N/A	DWS Full Width?	N/A
N/A	Landing Curb? (Y/N)	N/A	N/A	DWS Offset (in)	N/A
N/A	Shared Landing?	N/A			
N/A	Gutter Ponding?	N/A	N/A	Gutter Slope (%)	N/A
N/A	Gutter Lip Ht (in)	N/A	N/A	Gutter X Slope (%)	N/A
N/A	Painted X Walk1?	No	N/A	Painted X Walk2?	N/A
	X Walk 1 Direction	To S		X Walk 2 Direction	N/A
N/A	X Walk 1 Width (in)	N/A	N/A	X Walk 2 Width (in)	N/A
	X Walk 1 Slope (%)	0.3		X Walk 2 Slope (%)	N/A
	X Walk 1 X Slope (%)	1.7		X Walk 2 X Slope (%)	N/A

N/A	Ramp inside XWalk1?	N/A	N/A	Ramp inside XWalk2?	N/A
	Road Slope (%)	N/A	N/A	Clear Space?	N/A
	Road X Slope (%)	N/A	N/A	Clear Space to XWalk (in)	N/A
N/A	Any Obstructions?	N/A	N/A	Storm Grate/Utility Hazard?	N/A
	Obstruction Type			Storm Grate/Utility Type	
		N/A			N/A
			Yes	Surface Condition? (G/P)	Good

**Remove & Replace Entire Ramp.**
